**GEOLOGIC CONTROLS FOR LANDSLIDES IN
THE CENTRAL AMERICAN HIGHLANDS OF
NORTHERN EL SALVADOR**

**By
York W. Lewis**

**Submitted in partial fulfillment of the requirements for the degree of
Master of Science in Geological Engineering**

Michigan Technological University

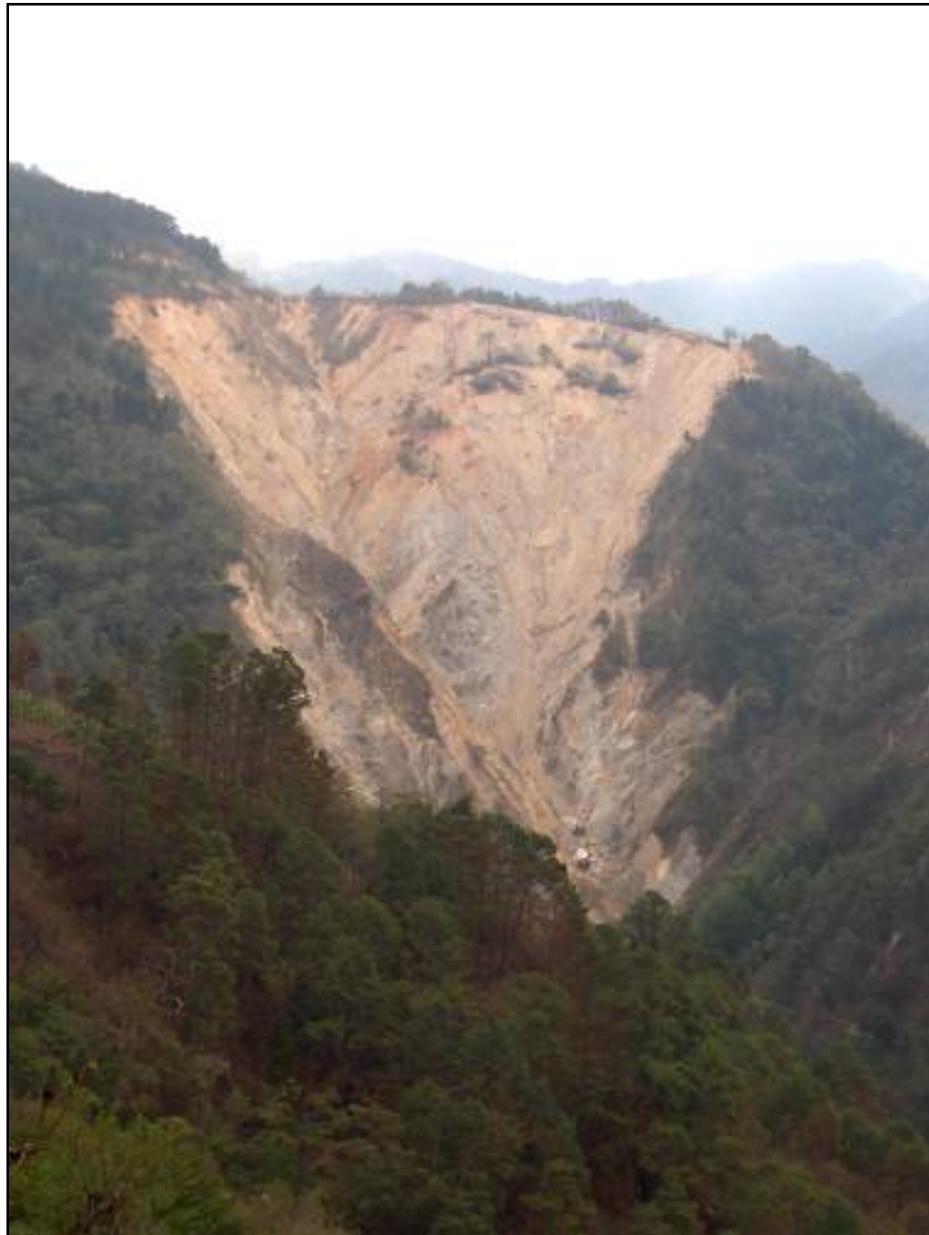
Another significant historic landslide occurs within the municipality of La Palma, El Salvador. According to local residents, the landslide complex, named “La Zompopera” (Figure 4) began roughly 50 years ago. Since its initiation, the landslide has grown to become the largest active landslide in El Salvador and one of the largest active landslides in Central America. The problems posed by this landslide are the continuous erosion of the road that wraps around the scarp of the landslide and the loss of fertile land for coffee growing and other agricultural uses. The local government’s response has been to move the road farther up on the ridge, but the road has currently reached its upper limit and can no longer be moved (Figure 5, Figure 6). This is an ongoing risk to the local and commercial traffic that use this road in order to reach the town of Miramundo and other villages at the top of the mountains (Figure 7). Other attempts at preventing further slope

failures have been the planting of grasses and small shrubs in order to anchor the soil. Since the failures are at bedrock/soil interface, the planting has been relatively ineffective at stabilizing the slopes.

Figure 4 Photo of the landslide Zompopera.

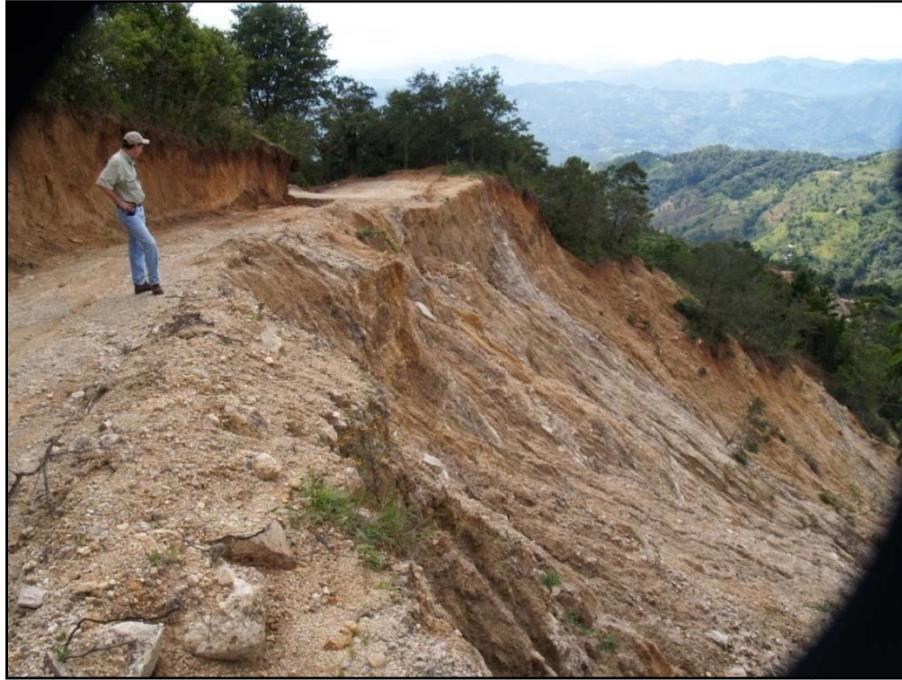
Figure 5 Photo of washed out portions of the road from La Palma to Miramundo at Zompopera.

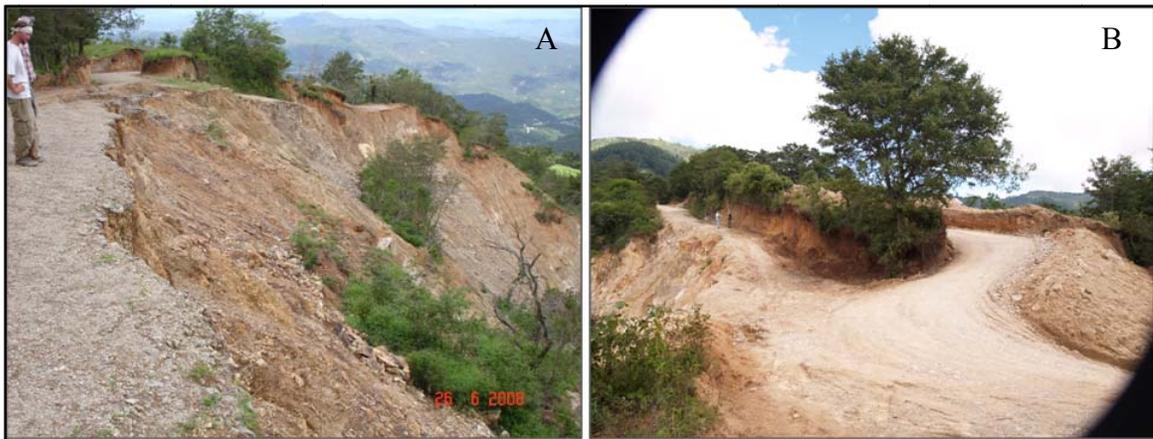
Figure 6 Photo A shows in the background the washed out road at Zompopera in June of 2008. Photo B shows the road at Zompopera before it had completely washed away and the recently constructed detour around the original path in November of 2006.

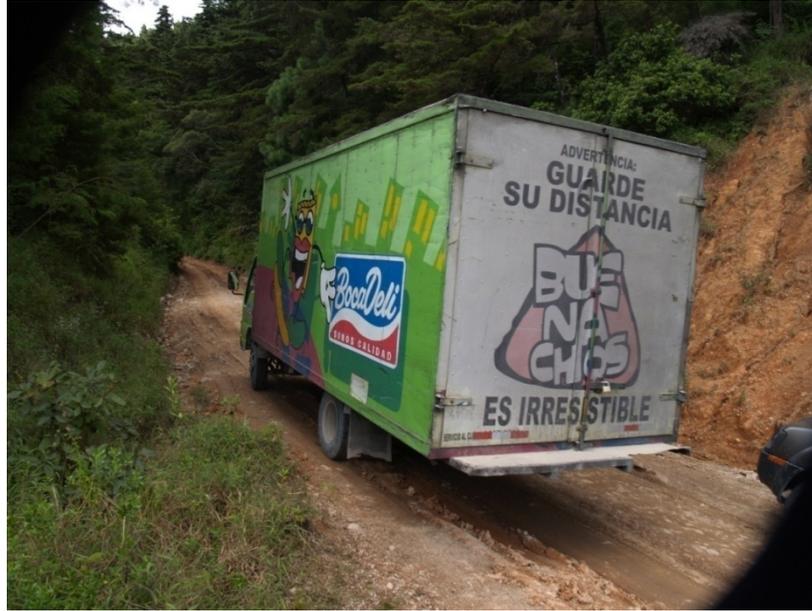
Figure 7 Photo of snack truck just passing the Zompopera landslide. Heavy commercial traffic is at a high risk of causing or being caught in slope failures on the weakened roads at the Zompopera scarp.

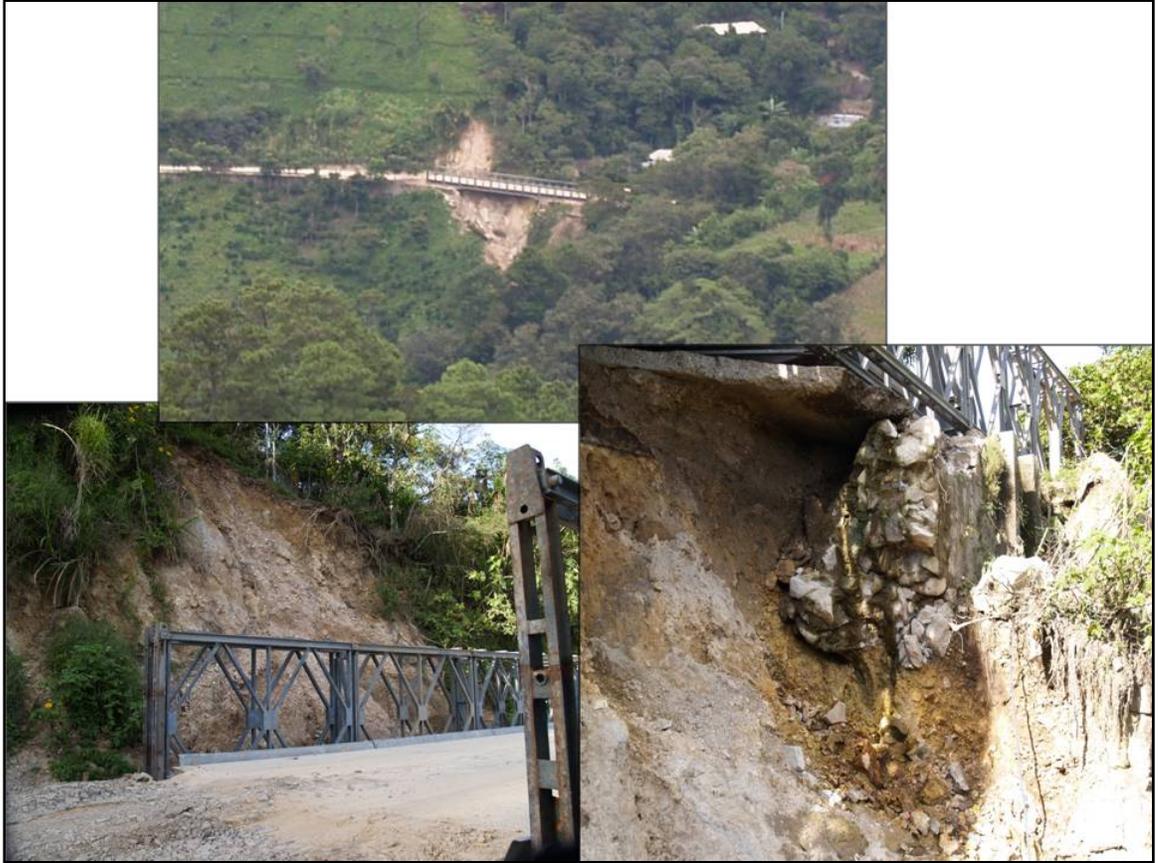
More recently, the road leading to the town of Teocinte, San Ignacio was washed out by a landslide during heavy rains in September of 2006 (Figure 8). For over a week the people had to get off buses and cross the scarp on foot to get on a bus on the other side of the landslide in order to move up and down the mountain. Las Pilas and the surrounding towns located at the top of the mountains are large producers of cabbage and other produce that grow in cooler climates. These products had to be carried off of large trucks and carried to the other side of the landslide to be brought to the markets. The Ministry of Public Works eventually installed a temporary Bailey bridge and after several months later, a permanent structure was constructed.

Figure 8 Photos of road destroyed by heavy rains in September of 2006. The Ministry of Public Works constructed a temporary bailey bridge until reconstruction of a permanent structure could be built.

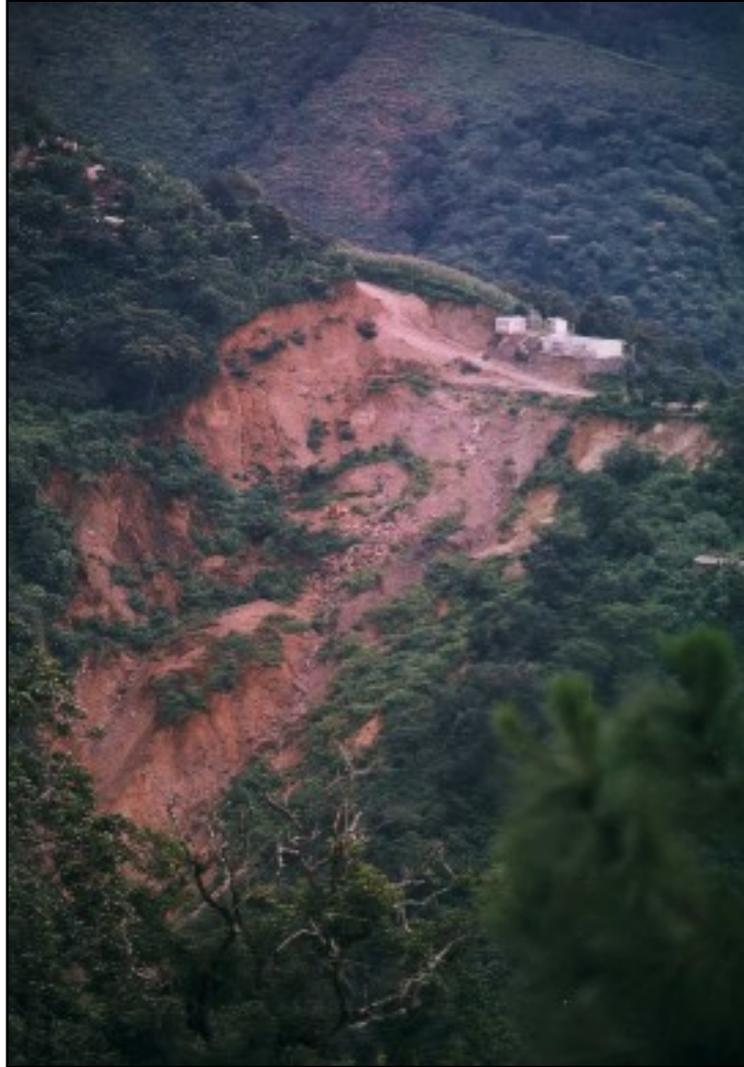
During Hurricane Mitch, a large landslide (Figure 9) occurred near the small community of Bella Vista, in the municipality of La Palma. It destroyed approximately 50 meters of the main road and undercut part of the foundation of a school (Crone, 2001). Today, the school has been removed; the road has been redirected to the top of the ridge, and a series of drainage ditches have been constructed along the stretch of road that the landslide scarp spans.

Figure 9 Photo from CEPRODE of Hormiguero taken several months after the landslide occurred. The road was redirected along the top of the scarp.

According to the USGS Open File Report 01-444, Hormiguero was caused by Hurricane Mitch (USGS 2001). This implies that under normal climatic conditions, the slopes are relatively stable and well drained. When high rainfall over short periods of time, like hurricanes and tropical depressions, occur the soil saturates and there is an increase in overburden stress.

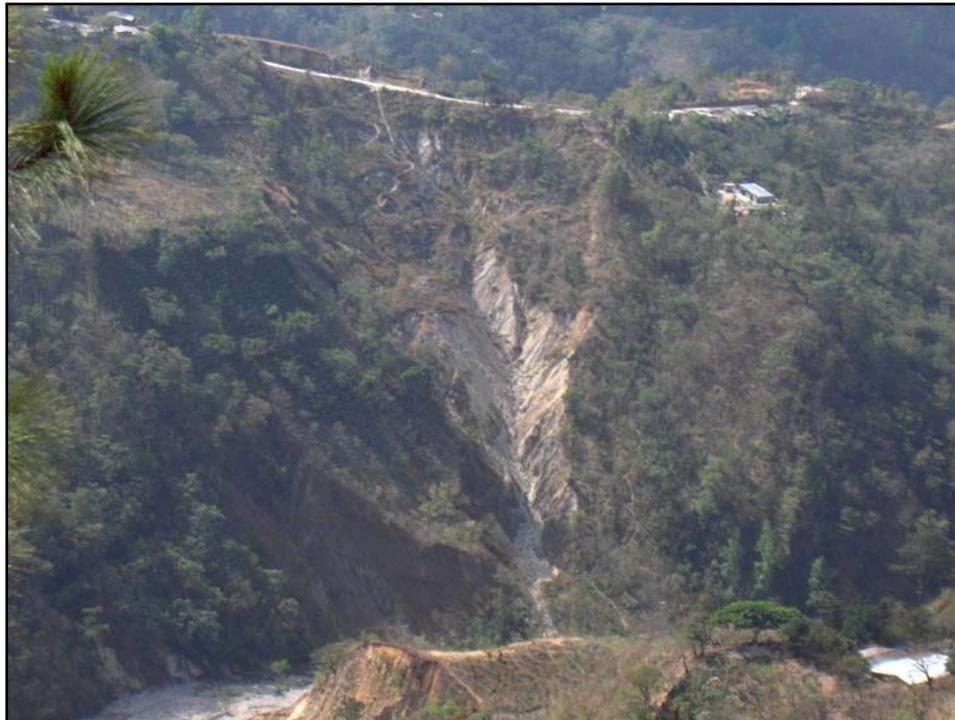
Figure 12 Photo of the landslide at the village of Bella Vista, locally known as Hormiguero.

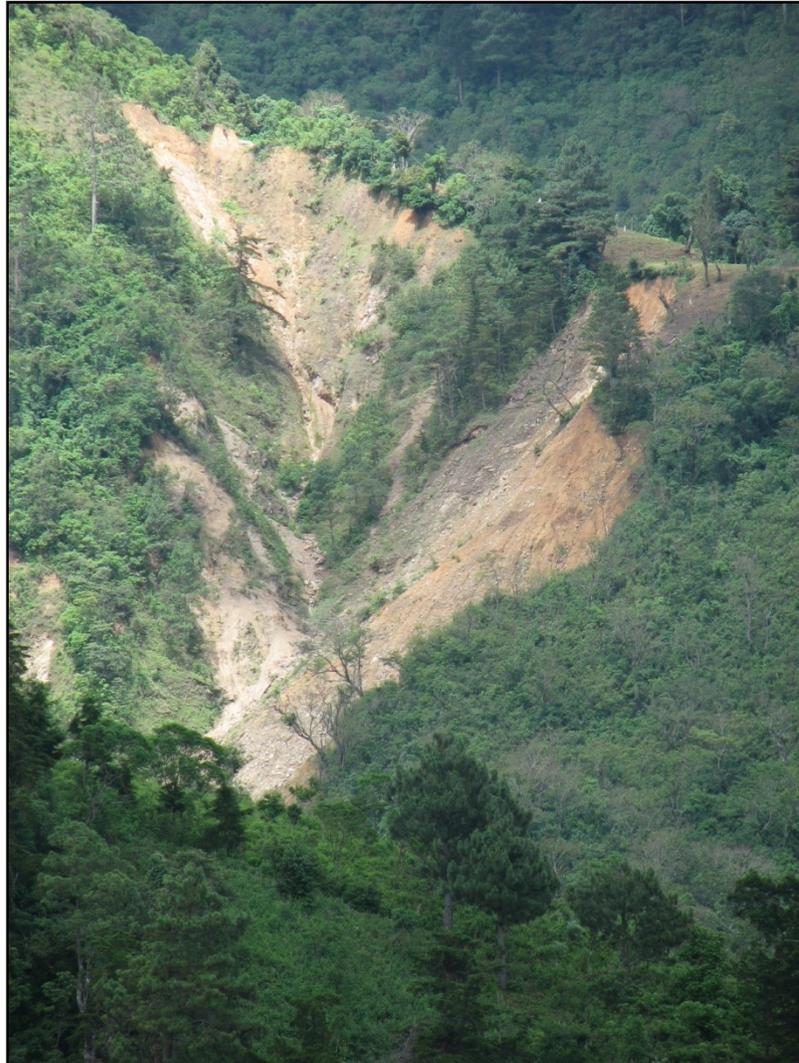
Figure 13 Photo of the landslide at the village of Las Duanas.

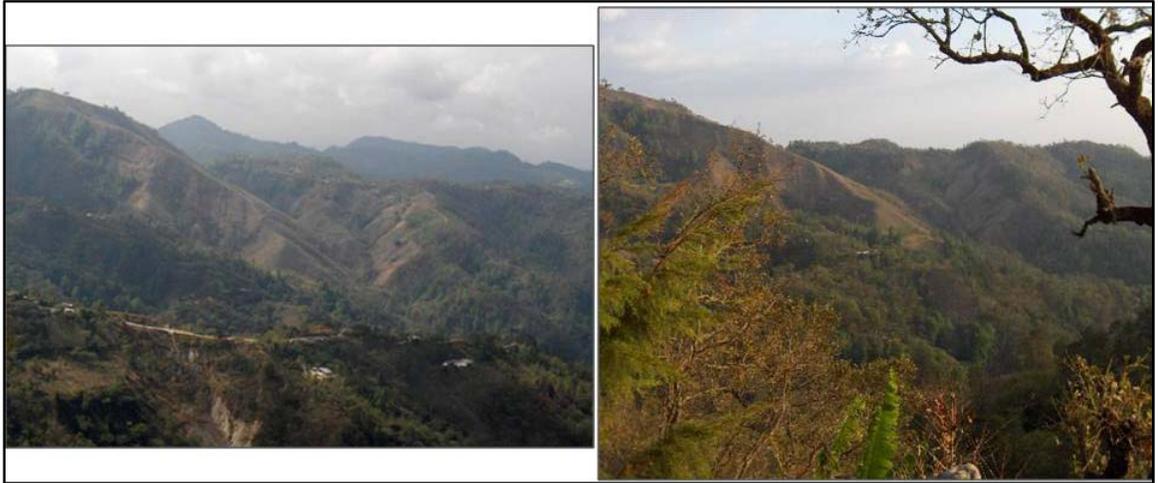
Figure 15 northwest-southeast trending fault blocks with the landslide Hormiguero in bottom foreground (left). Additional photo of northwest-southeast trending fault blocks from the road at Hormiguero (right). These are believed to be associated with the current regional extension caused by the Motagua fault movement between the North America plate and the Caribbean plate.

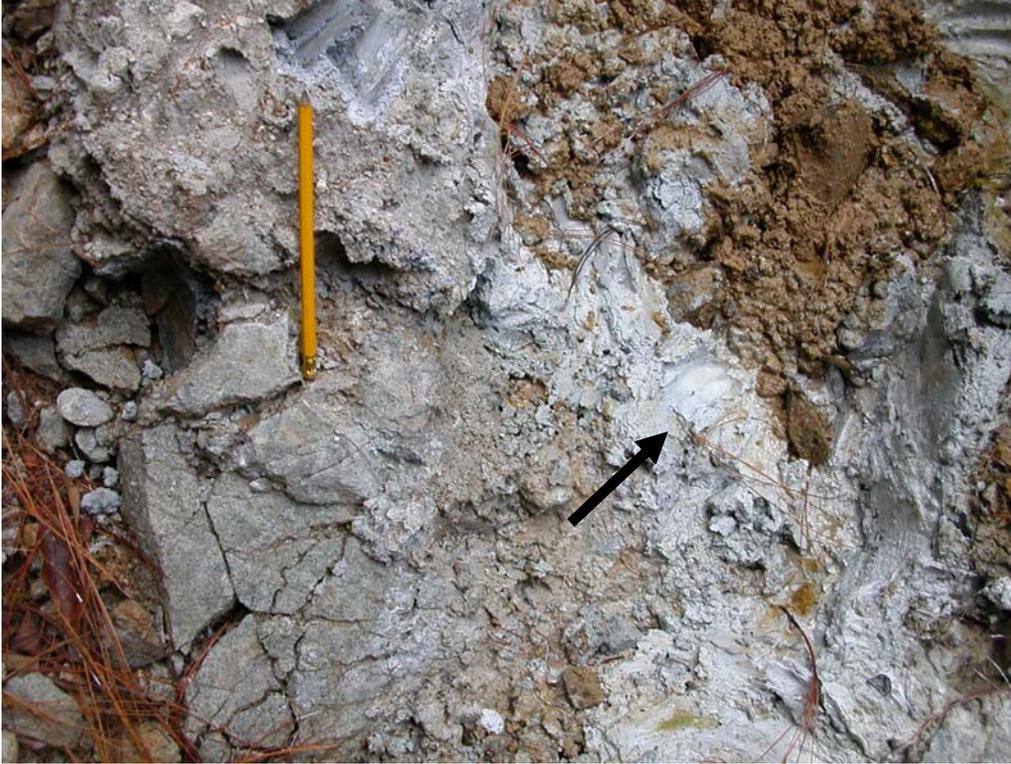
Within some of the rock joints of the Chalatenango formation, at Hormiguero and the landslide at Las Duanas, well-developed clay lenses were also observed. Atterberg limits were performed on six clay samples extracted from between joints at each landslide in order to determine their strength (Table 1).

According to a report done by COSUDE, the clays present in the clay fractures are illite and smectite. The X-ray diffraction analysis conducted in this study did not indicate the presence of smectites. X-ray diffraction on the parent rock shows the composition of the rock to consist primarily of quartz, calcite, albite, and orthoclase. We were unable to identify any mafic minerals in the rock samples. Illite and chlorite also appear in the X-ray micrographs of the parent rock as well do to partial weathering and hydrothermal alteration of the rock. X-ray diffraction on these clays shows the presence of quartz, illite, sodium-rich feldspars (albite) and potassium-rich feldspars (orthoclase), with trace amounts of chlorite and calcite. Illite is generally associated with the weathering or hydrothermal alteration of muscovite and feldspars, whereas chlorite is generally associated with the hydrothermal alteration of mafic minerals such as pyroxene, amphibole, or biotite.

Figure 18 Photo of Ignimbrite weathering to clay. These clays are believed to have been developed by groundwater seeping through joints within the ignimbrite bedrock.

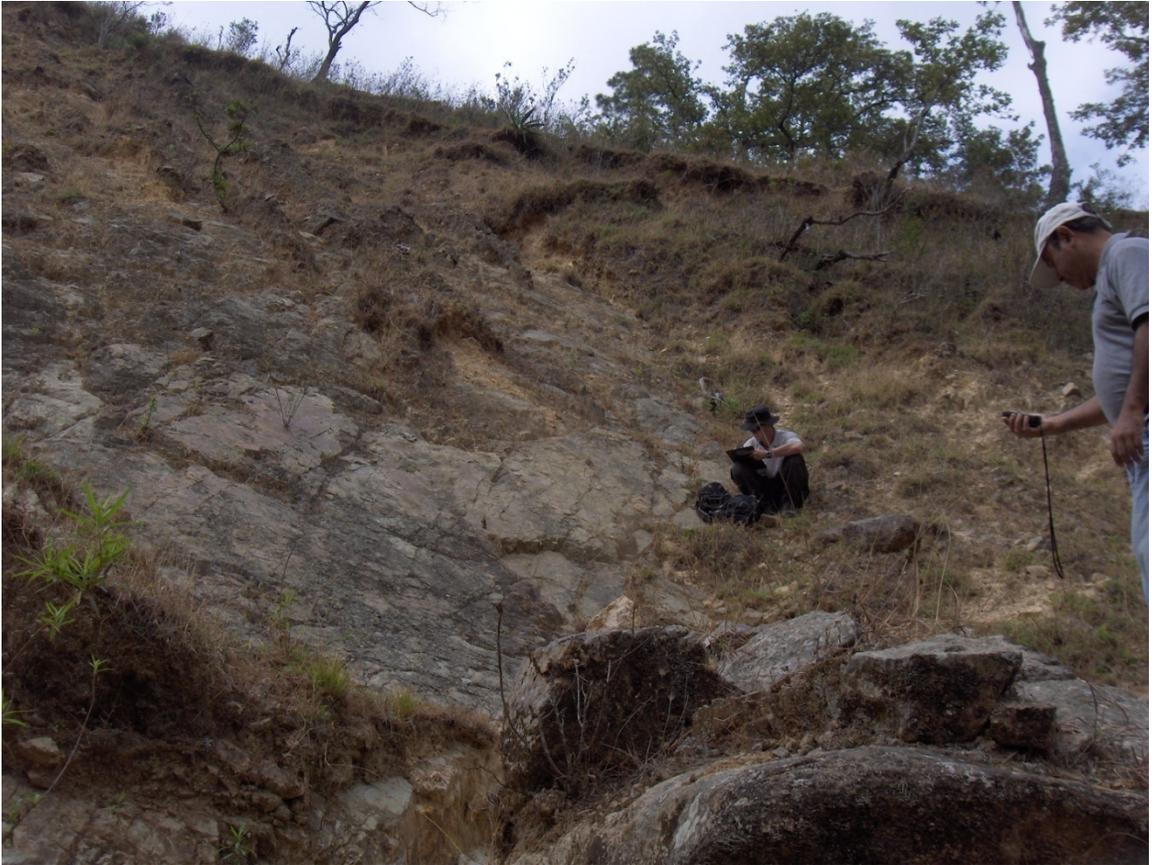
The soils of at higher elevations above La Palma and San Ignacio are classified as latosols (Rico 1974). Latosols are characterized as (1) being rich in Fe, Al, Si; (2) formed in tropical woodlands under very humid climates and with relatively high temperatures; (3) shallow A horizons but thick B horizons (comprised of clay, sand, and sesquioxides of Fe and Al); (4) red in color; and (5) low fertility due to the leaching of the minerals. Latosols, even with seasonal rainfall changes and deep water tables, also appear to maintain some water content all year round (Wesley 1973). The study area surrounding the Las Duanas landslide and Hormiguero, soils are approximately 2 to 3 meters thick and directly overlie the Chalatenango ignimbrite. We see a distinct unconformity between the low lying ignimbrite and the soil layer (Figure 23) where there is an absence of a rock to C horizon transition (Figure 23).

Figure 23 Photo of the soil rock unconformity. Note the sharp unconformity between the regolith and the bedrock. Rock blocks spall/pluck from the rock mass once exposed.

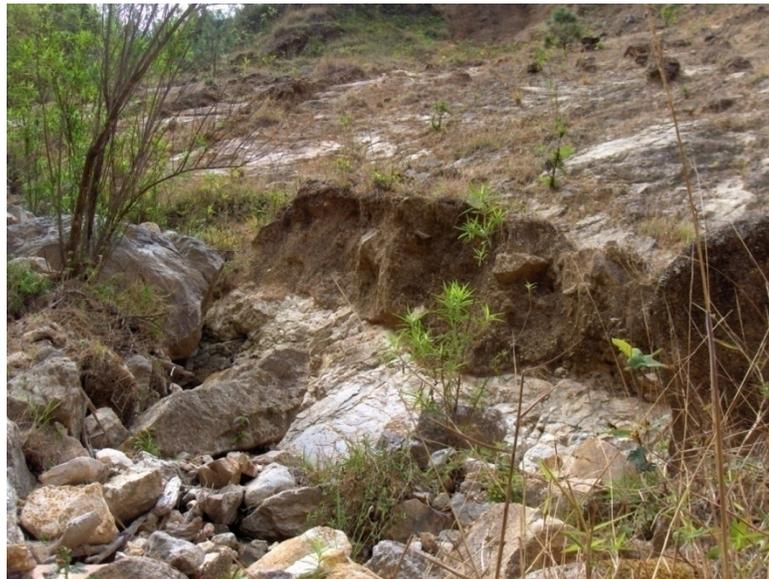
Tropical residual slope failures in Dominica, West Indies following hurricane David and Fredrick in 1979 were investigated by Rouse (1986). He found that these tropical soils had unusual geotechnical and hydrological characteristics and that slope failures on soils containing allophane tend to be translational at shallow depths less than 2 meters at the regolith/rock interface. In this study, field and photo analyses also suggest that slope failures are translational failures of approximately 2 to 3 meters thick soils and on steeply dipping rock surfaces. In the neighboring drainage to the west of the Las Duanas drainage, an additional small landslide was found and is shown in Figure 30. This landslide shows a clear translational failure mode with about 2 meters of soil overlying an ignimbrite rock surface. It can also be observed from this figure that the rock slip surface also appears to have been smoothed by previous translational failures. The failure surface extends to the north-eastward along a 56 degree dipping surface of the acidic ignimbrite material.

Figure 30 Photo of smaller slope failure at the base of the Las Duanas Landslide. Note the soil mass that has slide down the rock surface.

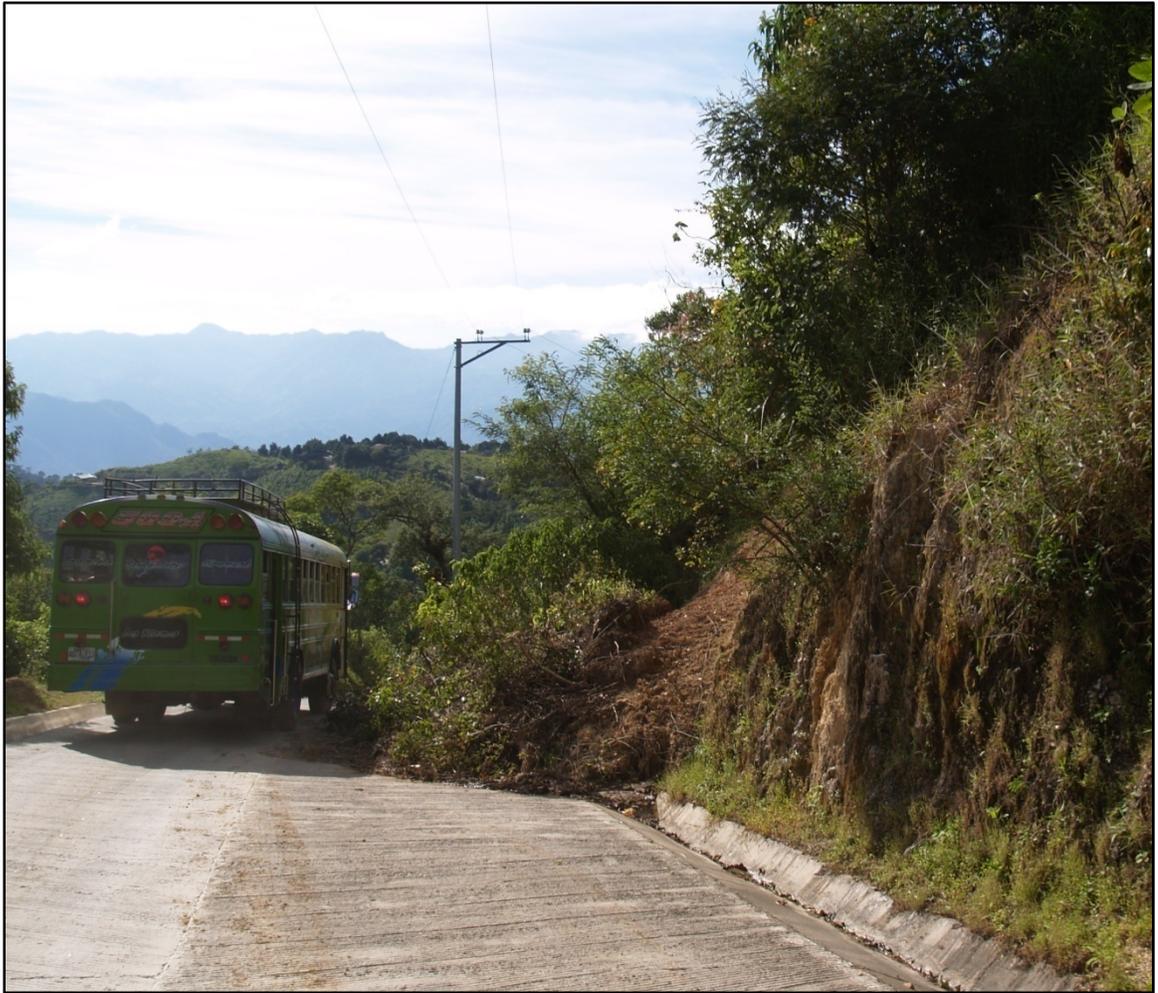
Figure 34 Small landslides along road cuts dot the roads after heavy rainfall during the rainy season.
