**Fiji Islands' Naboro Landfill Leachate
Quality Analysis and the Applicability of
Developed versus Small Island
Developing State Discharge Standards**

MASTER OF SCIENCE IN ENVIRONMENTAL ENGINEERING

MICHIGAN TECHNOLOGICAL UNIVERSITY

2009

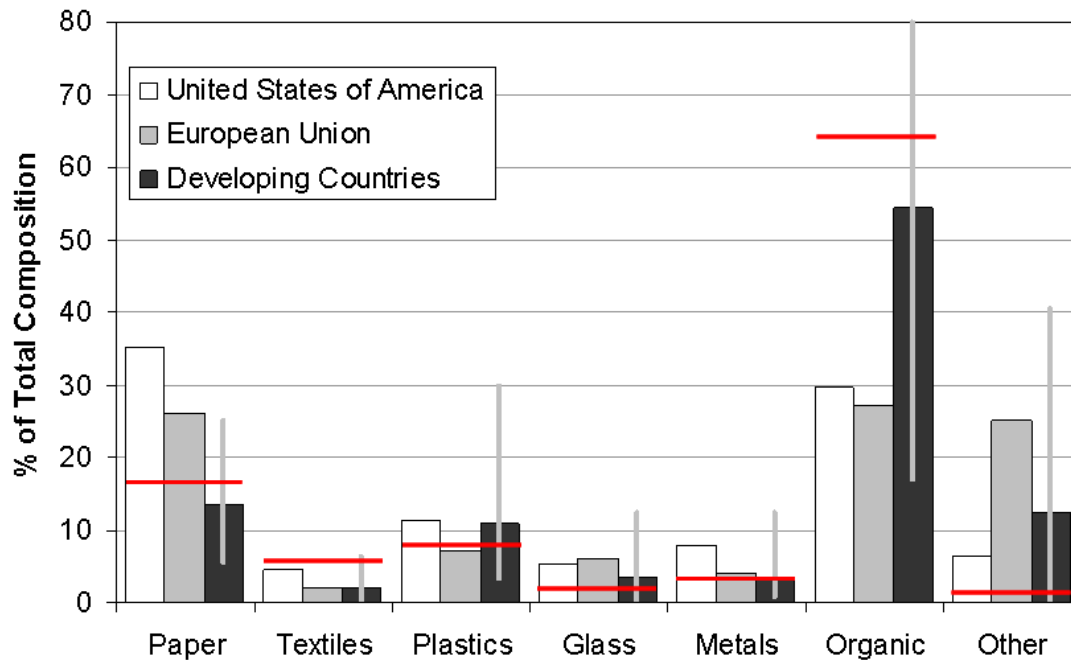
Figure 4: Difference between MSW compositions in developed countries versus developing countries with Suva region values superimposed in red for comparison (Troschinetz and Mihelcic, 2009).

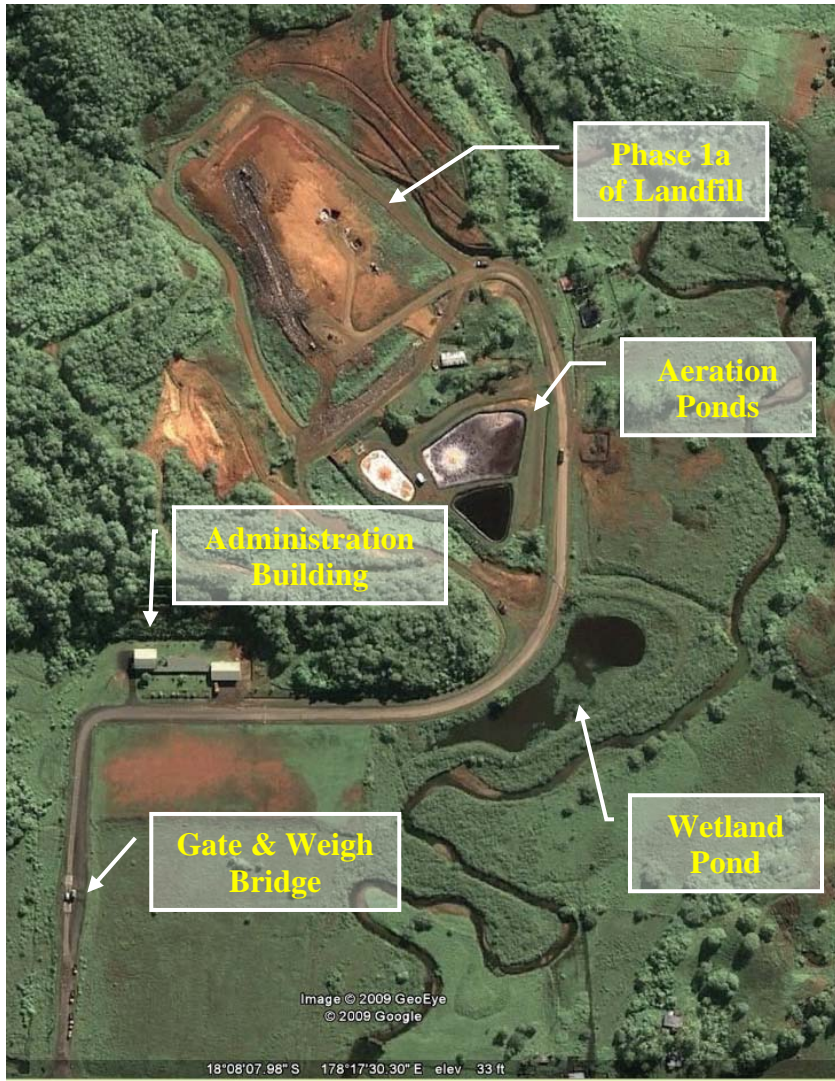
Figure 6 shows the layout of the Naboro Landfill compound. The solid waste collection trucks arrive at the gate and proceed to the weigh station for their incoming load measurement. After weighing in, the trucks drive past the administration building, mechanic workshop, and leachate treatment system area, to arrive at the landfill tipping area. The trucks unload their waste into the designated tipping area that is being supervised by the operating company. The trucks are then given the opportunity to rinse their truck beds and wheels before exiting the tipping area. Once the trucks leave this area, they drive back to the weigh station where the exit weight is recorded before they depart the landfill compound.

Figure 6: Naboro Landfill compound layout (Google Earth, 2009).

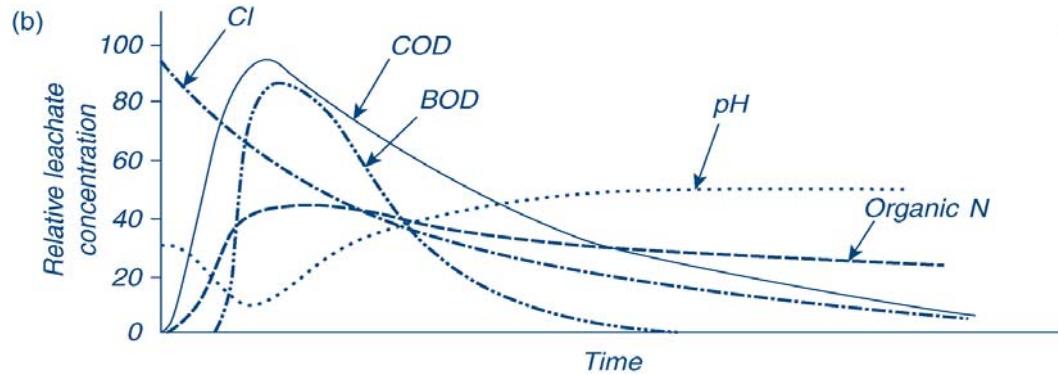
For developed countries, Figure 7 depicts relative expected landfill leachate constituent concentrations over time.

Figure 7: Relative expected leachate composition concentrations for developed countries over time as the organic waste decomposes within the landfill. (Mihelcic and Zimmerman, 2010)

The time for landfill leachate to progress along these trend lines varies between landfills. The peaks of the BOD and COD concentrations correlate to the maturation of the landfill leachate. This maturation can occur anywhere from two to twenty years, depending on the site characteristics of the landfill. During the earlier stages of decomposition, the oxygen content is being consumed and carbon dioxide and organic acids are being produced. This creates a low pH and a high oxygen demand as a result of organic particulates being converted to a dissolved phase; high oxygen demand correlates to high BOD/COD concentrations. As time progresses, the oxygen is depleted and the waste undergoes anaerobic decomposition. Microorganisms convert the BOD organic acids to methane gas thus creating a weakened leachate because the dissolved constituents convert to gaseous phase and readily leachable constituents become less prevalent (Mihelcic and Zimmerman, 2010).

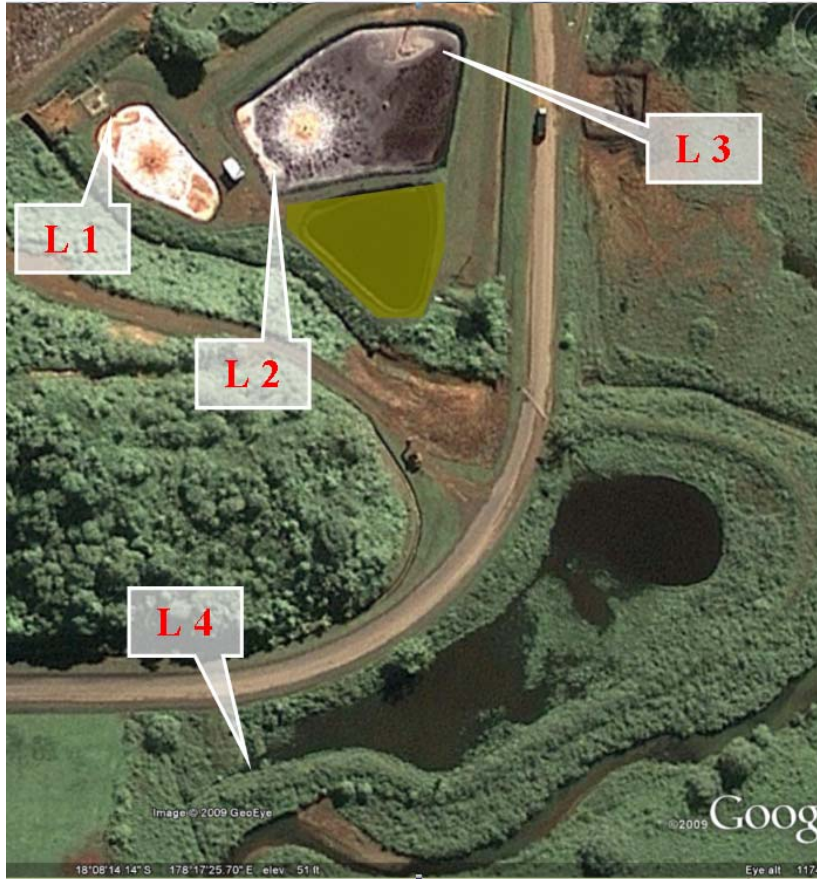
The next sampling events occurred on May 25, 2006 and June 1, 2006 (Table 6); undertaken by HG Leach who contracted USP-IAS as well for the collection and analysis. Each event included four sample points representing the progressive treatment points along the system. Figure 8 shows the Naboro leachate sampling points used for each sampling event performed in May and June 2006. The sampling points are labeled L1, L2, L3, and L4; the "L" representing leachate. L1 was located at the influent pipe from the leachate storage tank into Pond 1. L2 was located at the influent point of Pond 2. L3 was taken at the effluent point of Pond 2. L4 was taken at the effluent point of the wetlands.

Figure 9: Naboro leachate sampling points for tests done in May and June 2006 (Google Earth, 2009).

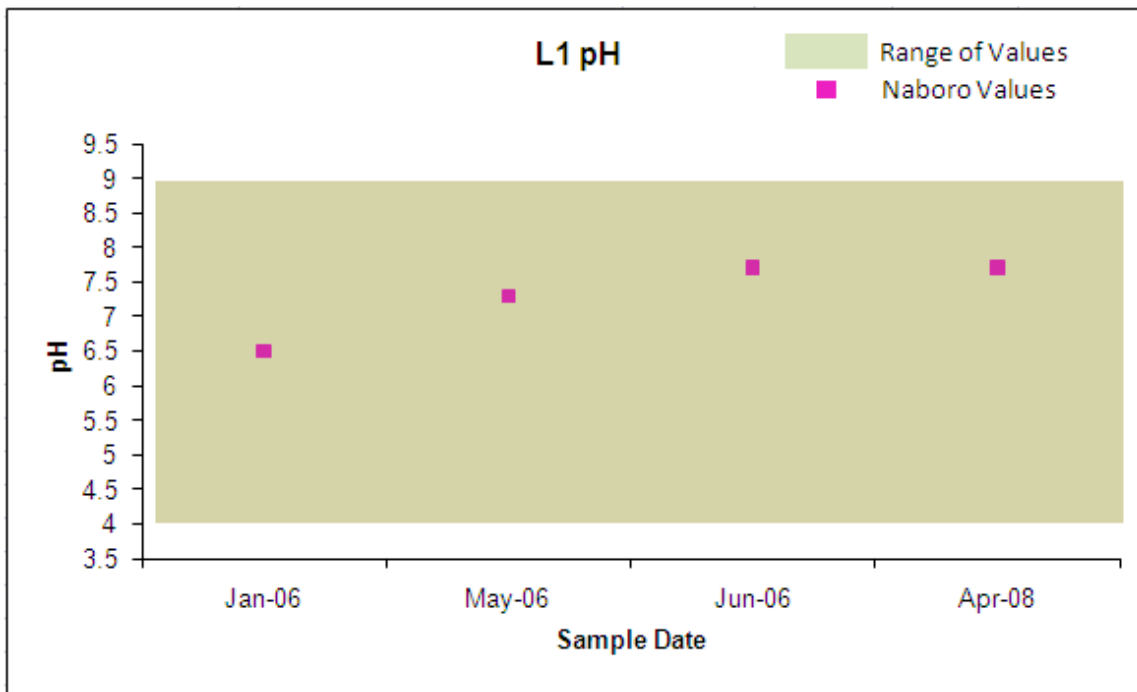
Figure 11: Measured pH values from sample point L1 compared to observed range of values for developing country leachate.

Figure 11 shows that pH values remained well within the range of expected values 4 to 9.

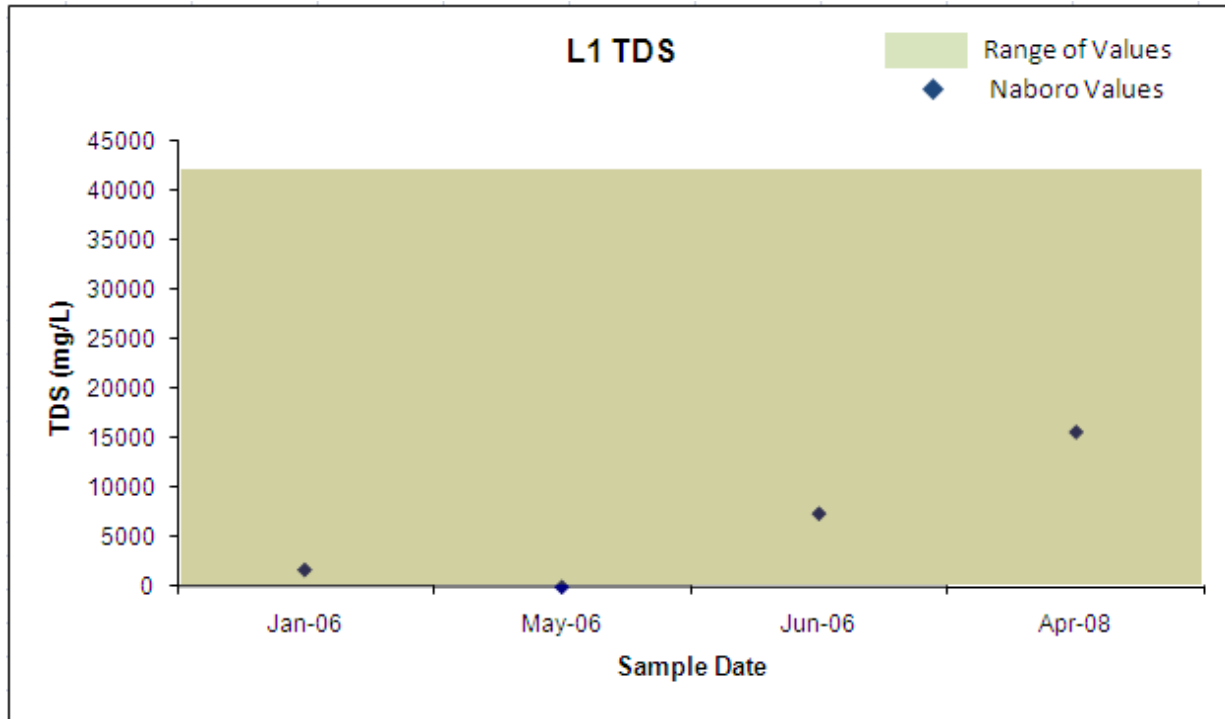
Figure 12: Measured TDS concentrations from sample point L1 compared to observed range of values for developing country leachate.

Figure 12 shows Naboro TDS concentrations were in the lower range of the 0 to 42,300 mg/L concentrations listed in Table 2. The smallest concentration was reported on May 2006 with a TDS of only 6 mg/L and the highest concentration in April 2008 of 15,616 mg/L. A low TDS indicates a low mobilization of dissolved ions that includes metals which is positive for the overall leachate system.

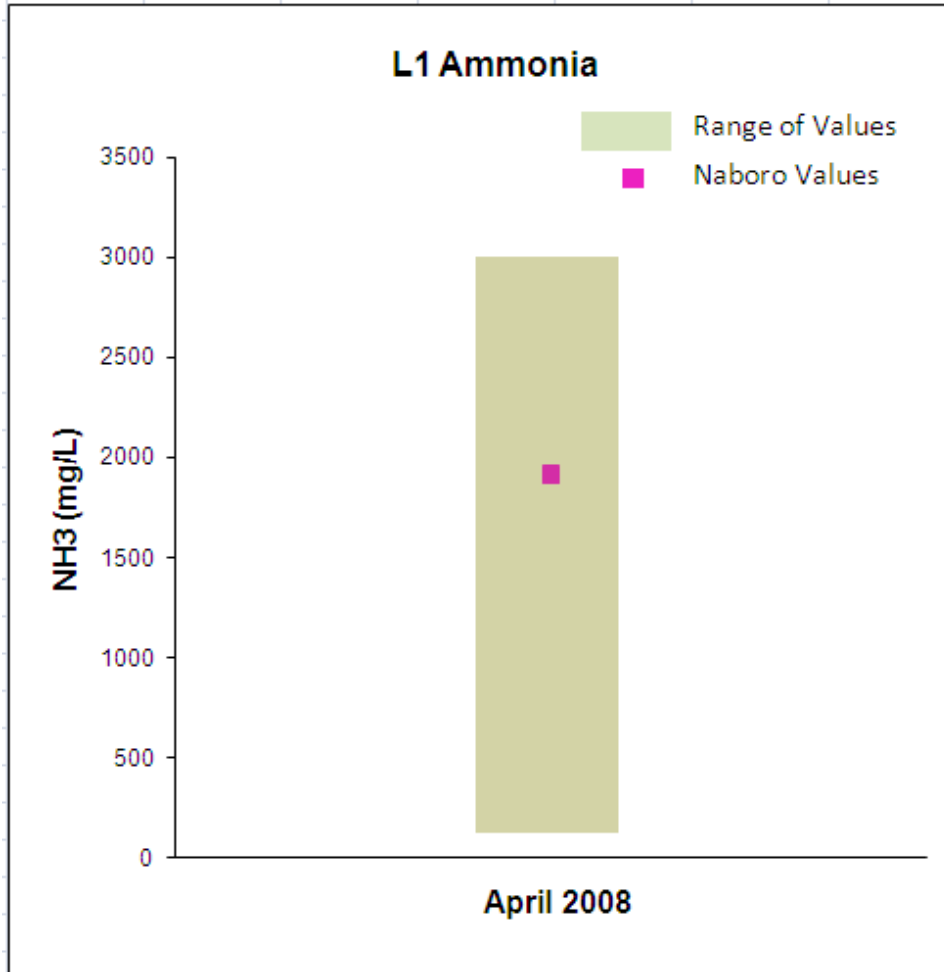
Figure 13: Measured Ammonia concentrations from sample point L1 compared to observed range of values for developing country leachate.

The ammonia concentration at Naboro was reported just above the mid-range values (1,914 mg/L) in Table 2, as shown in Figure 13. This is not surprising in that the values for Ammonia were from samples collected prior to the installation of the aerators. The increased oxygen and turbulence created by these new aerators should increase the removal of ammonia by stripping and oxidation to nitrate by biological nitrification.

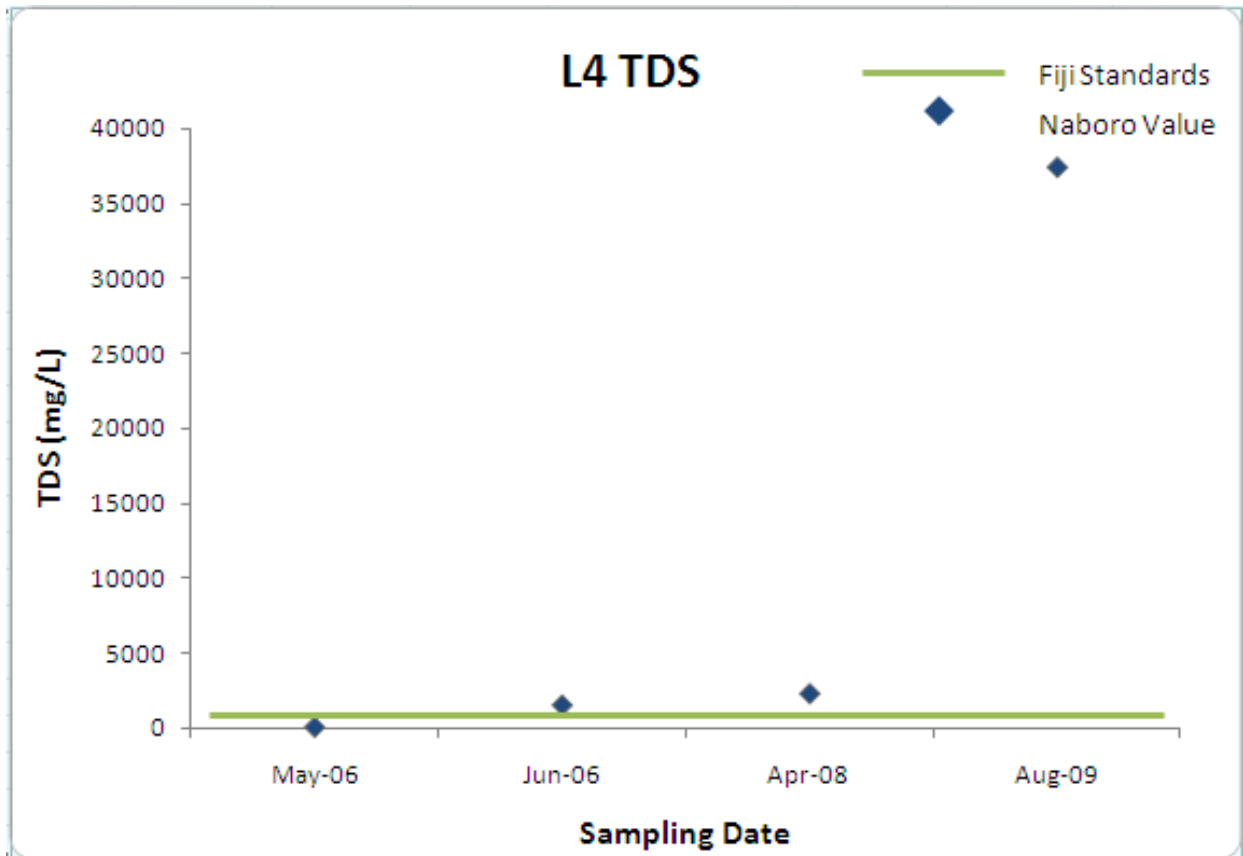
Figure 16: Measured TDS concentrations from sample point L4 compared to Fiji effluent standards.

The TDS trend over the sampling dates, displayed in Figure 16, started off low with a concentration of 2 mg/L but has increased significantly over the leachate testing period. The resulting differential from the effluent standards set by Fiji is higher by 478 mg/L in June 2006, 1,240 mg/L in April 2008, and 36,376 mg/L in August 2009. It must be noted though that the Fiji National Liquid Waste standards are not meant for landfill leachate specifically. Landfill leachate will typically report higher TDS values than a wastewater treatment system. Therefore, it is understandable why this effluent standard is set so much lower than what the effluent leachate at Naboro is achieving. The US EPA did not specify an effluent standard for TDS but this value could be included in the NPDES permit given to a similar landfill facility in the US.
