A SANITATION PLAN FOR A FISHING VILLAGE IN JAMAICA THAT
INCORPORATES EVAPOTRANSPIRATION BED TECHNOLOGY

By
KELLY L. STANFORTH

MASTER OF SCIENCE IN ENVIRONMENTAL ENGINEERING

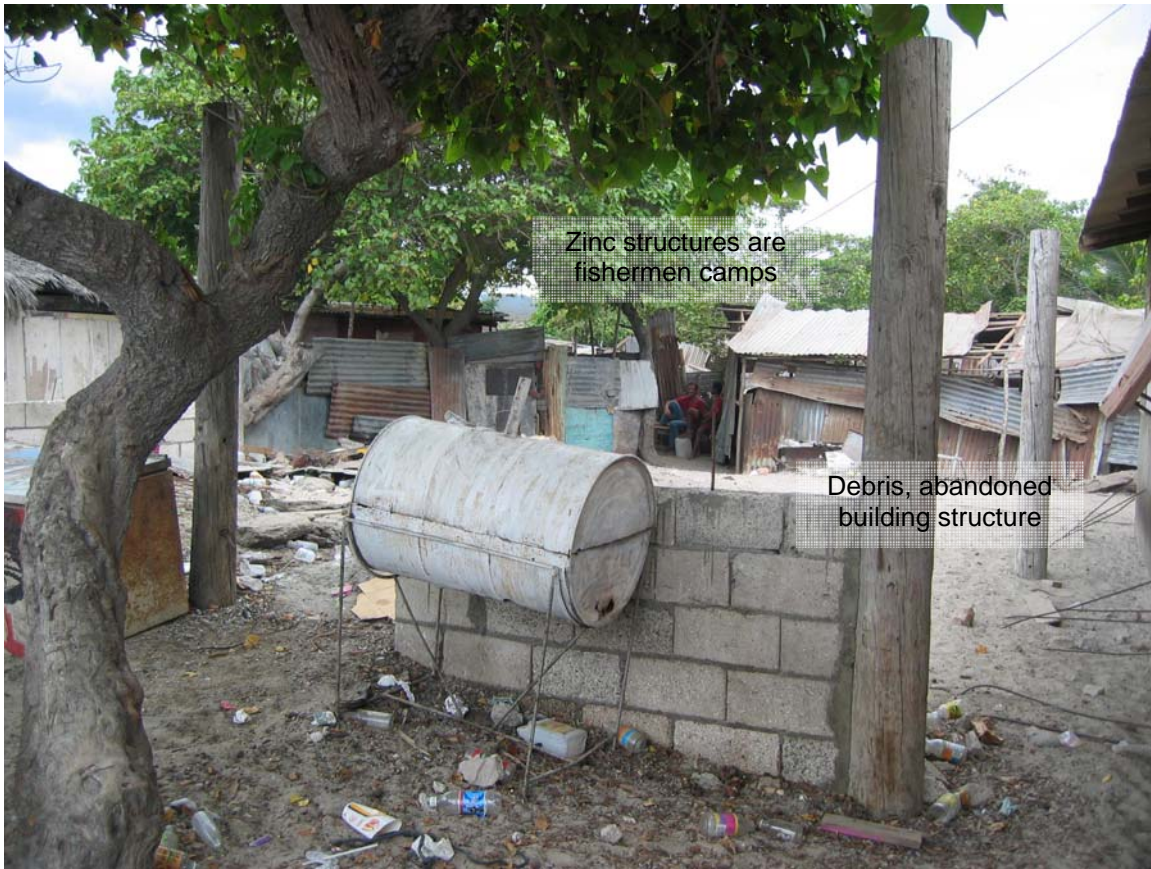
Figure 5: Environmental Conditions at Half Moon Bay.

Notice the debris in the sand and densely spaced zinc structures.

- Land use for construction of fishermen camps and fry fish sheds
- Vehicular traffic within 100 feet of the coast
- Poor sanitation practices, including the construction of pit latrines in the sandy soil structure
- Improper disposal of solid waste (Figure 5).

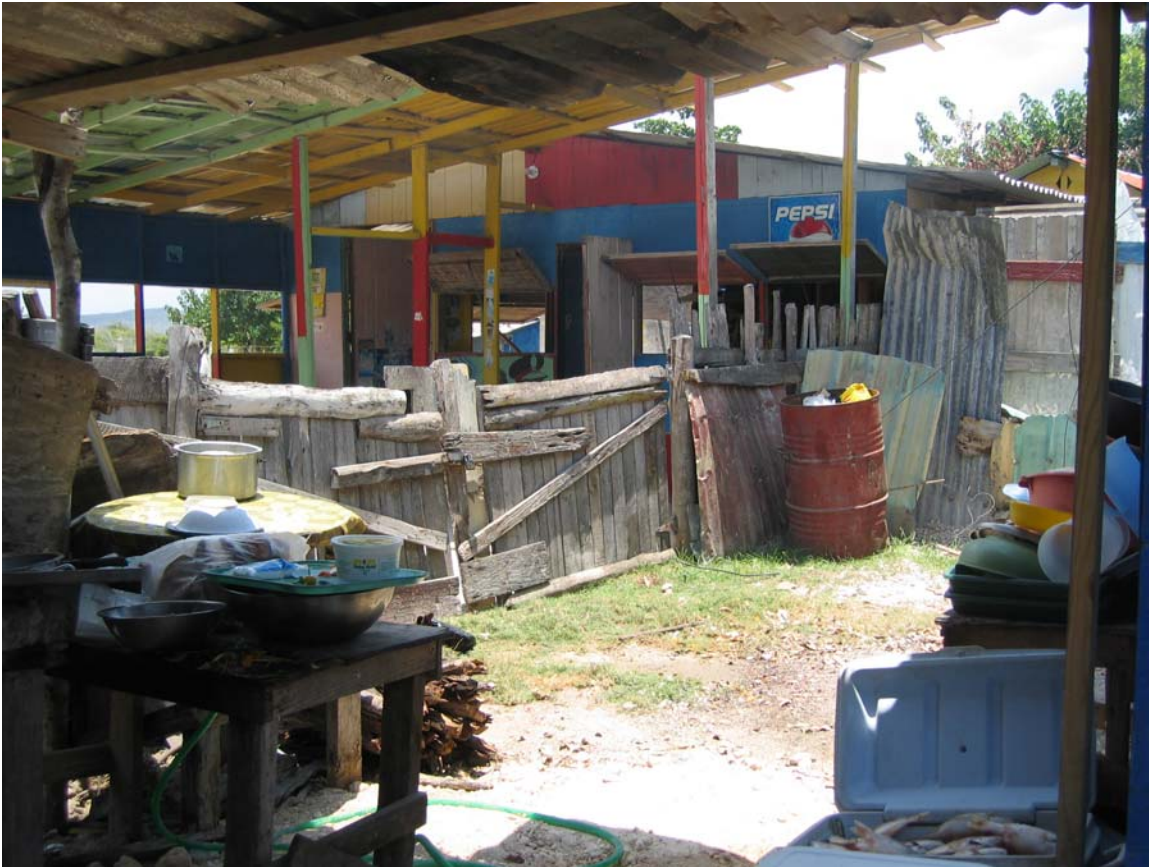
Figure 6: Typical Fishermen's Shed with Restaurant/Bar Attached at Half Moon Bay. Photo Courtesy of K Stanforth 2003

At Half Moon Bay, 62 fishermen have private camps to store personal fishing supplies and maintain a temporary sleeping quarters (Greater Portmore Health Centre, 2003). The camps are identified by their zinc or wood structures. Housing material is typically zinc, stone, concrete block, bamboo or wood (Figure 6). Approximately one-quarter of Camps have improved sanitation.

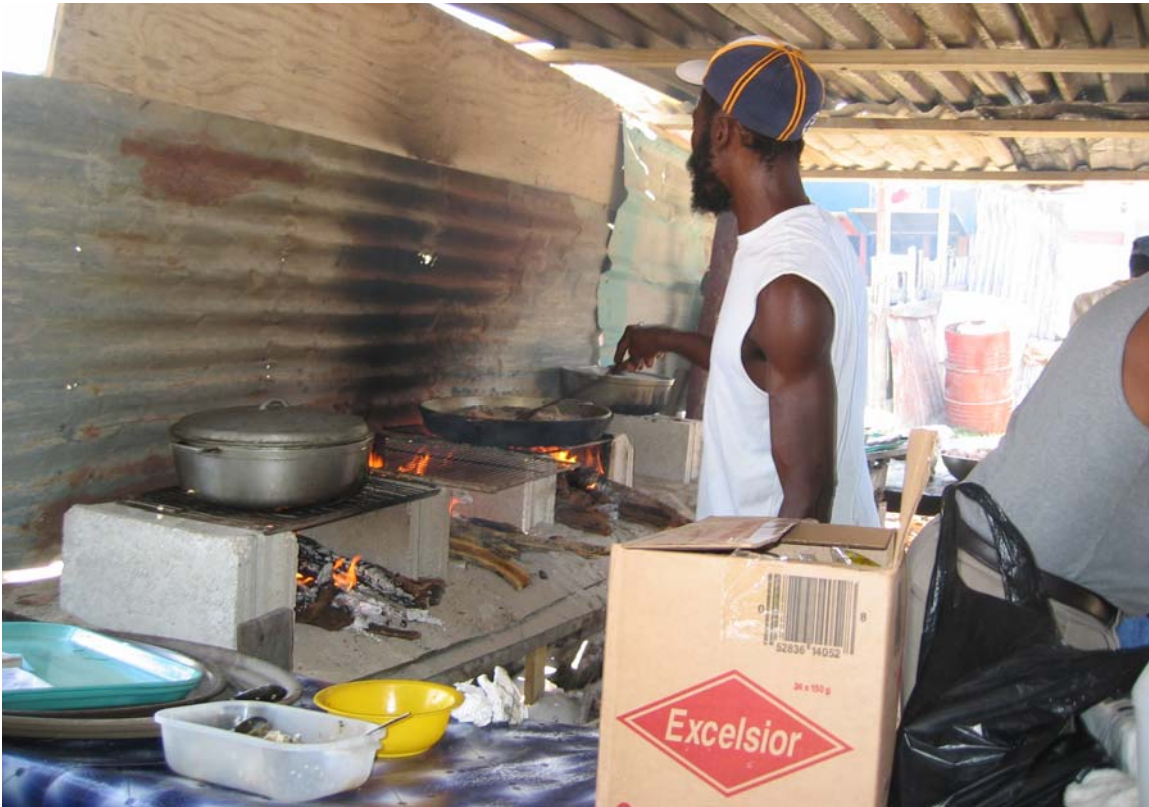
Figure 7: Typical Fry Fish Shed at Half Moon Bay.

along the south bathing area. The facilities are constructed with ply board, unfinished wood, zinc and concrete. The cooking area is a wood burning stove. Figure 7 is a typical fry fish shed cooking area. Table 8 is the number of camps and food/bar establishments that were operating from the beach in April 2003.

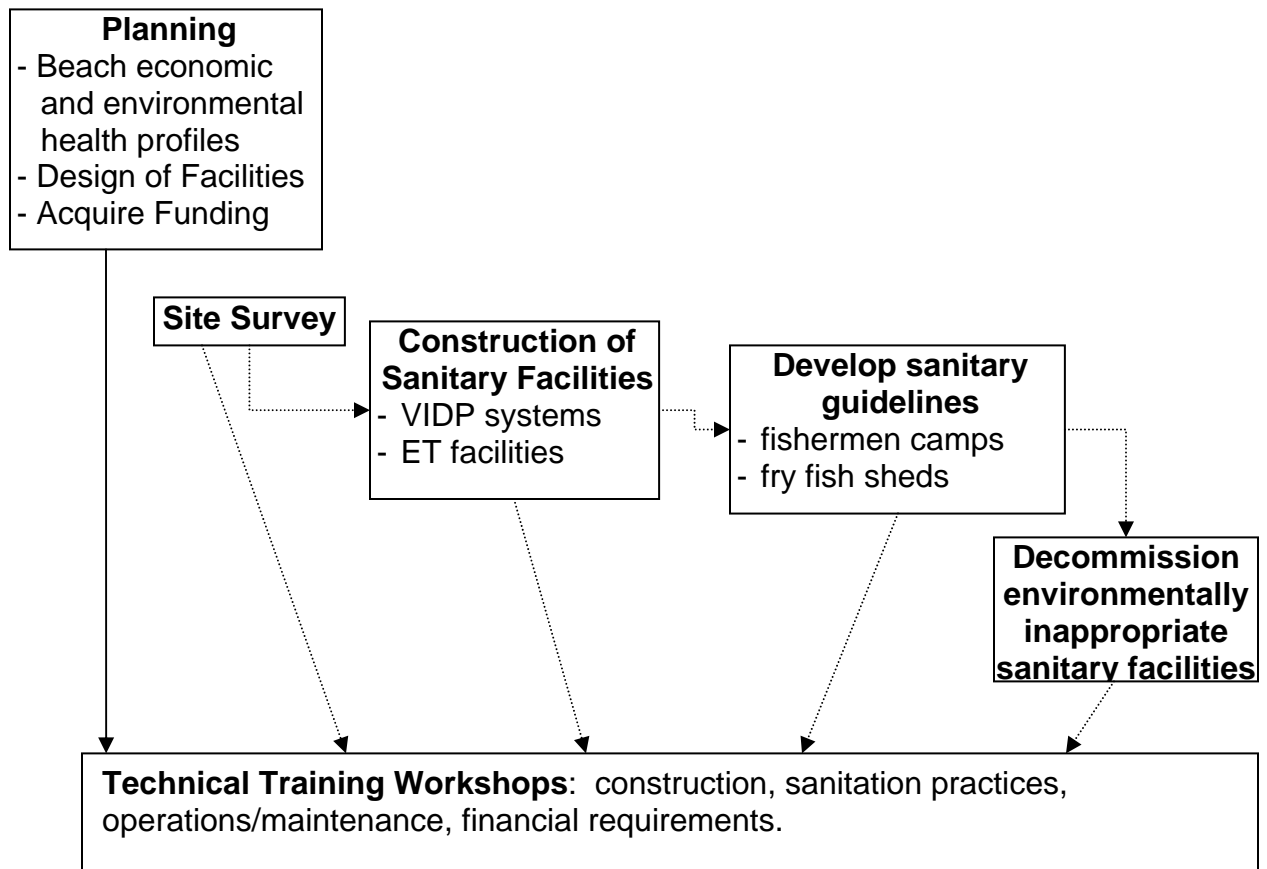
Figure 10: Components and Relevant Factors for Proposed Sanitation Plan

As chapters 4 and 5 emphasized, the Cooperative researched numerous sanitation solutions for beach. The first recognition was the need for different types of toilets, strategically located throughout the beach. The three (3) toilet systems are (1) public communal facilities for beach staff and visitors, (2) fishermen communal facilities for fishermen and overnight guests that do not have a private toilet facility and (3) fishermen improved sanitation facility design that will accommodate fishermen that plan to build a toilet system within their camp. The later is not addressed in the first phase of this sanitation plan. The Cooperative then established the most critical category as the public communal facility because of public health concerns for visiting patrons. A summary of components of the proposed sanitation plan are provided in Figure 10.

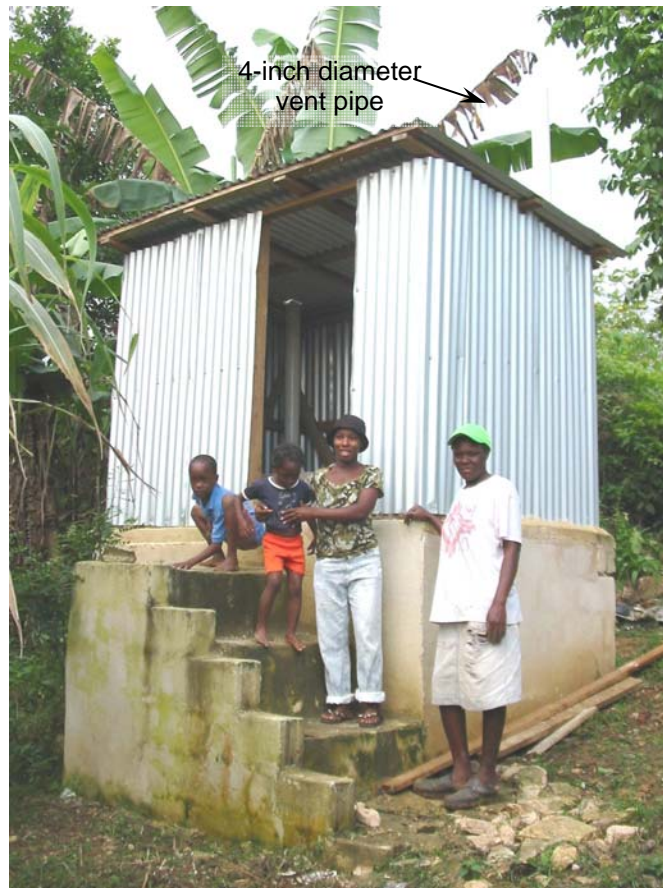
Figure 11: Ventilated Improved Double Pit Latrine (VIDP), Trelawny, Jamaica. Photo courtesy of Ben Liu, 2002.

VIDP system is an onsite excreta disposal system that does not employ the use of water as a carrier (Peasey, 2000). This dry sanitation technology has proven both successful and unsuccessful in numerous sanitation projects throughout the developing world (Franceys et al., 1992). The Cooperative proposed the installation of these systems to accommodate fishermen and overnight guests on the beach.

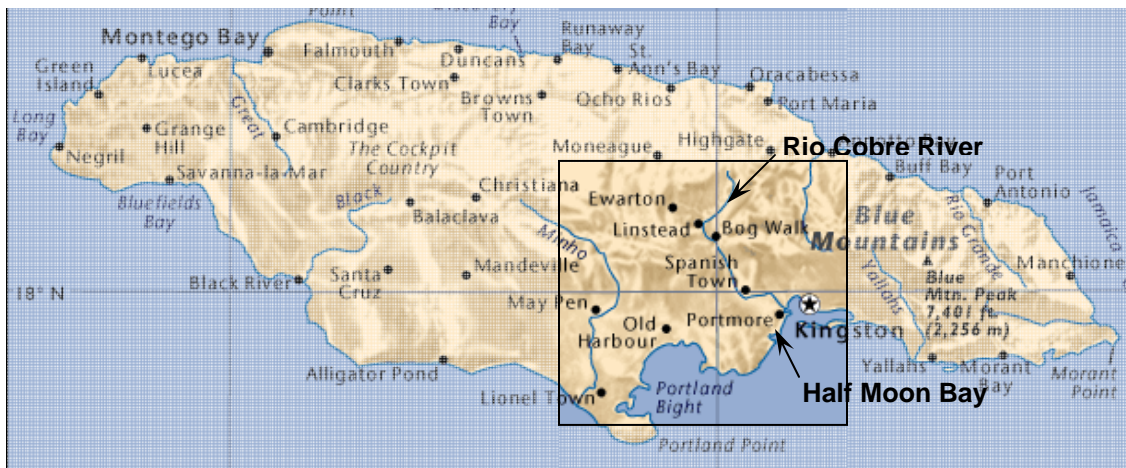
Figure 13: Jamaica Map, Identifying the Rio Cobre River

Precipitation and pan evaporation parameters employed for the design of the ET bed were acquired from the Rio Cobre Watershed area. Figure 13 identifies the Rio Cobre River. The data was obtained from the Water Resources Authority during the 30 year period, 1950 – 1980 at Bernard’s Lodge in Innswood, St. Catherine (Table 15, Figure 14). This site is approximately 24 km (15 miles) inland from Hellshire Beach. Bennett (et al, 1971) suggests evaporation and precipitation data from the critical one-year of a ten-year span is sufficient.

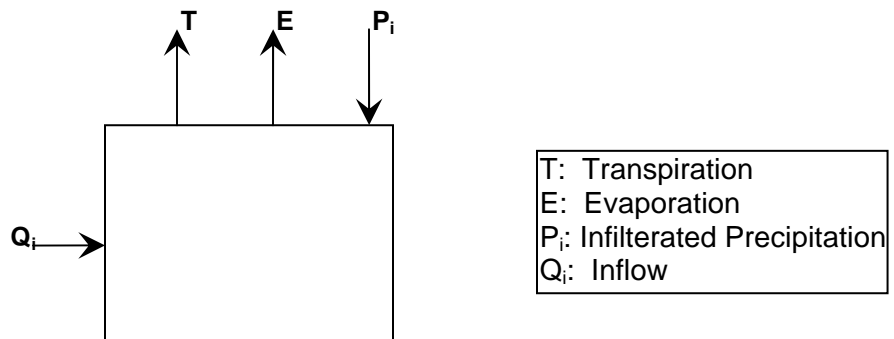
Figure 15: Water Balance

A water balance was conducted to determine the appropriate size of the evapotranspiration bed (Table 17). Factors included in this water balance study are transpiration (T), evaporation (E), infiltrated precipitation (P_i), wastewater inflow (Q_i) and wastewater outflow (Q_o) (Figure 15). The wastewater outflow is equivalent to zero because the design is based on non-discharging criterion. In order for an ET bed to operate properly, net evaporation and transpiration must exceed infiltrated precipitation and wastewater inflow. For two months (September and October), the evapotranspiration rate does not exceed the inputs, so the ET bed includes a storage area for the accumulated wastewater until evapotranspiration exceeds inputs and precipitation amounts are decreased. Maximum allowable depth to insure sufficient capillary action 610 mm (24 inches) (Salvato, 1992; Bennett et al, 1973; USEPA, 2002).

The ET bed system is designed for a maximum wastewater inflow of 1,050 Liters per day (280 US gallons per day). This is equivalent to twice the current demand at the beach on major holidays (Table 17). This assumption may be too low to accommodate the actual weekend demand.

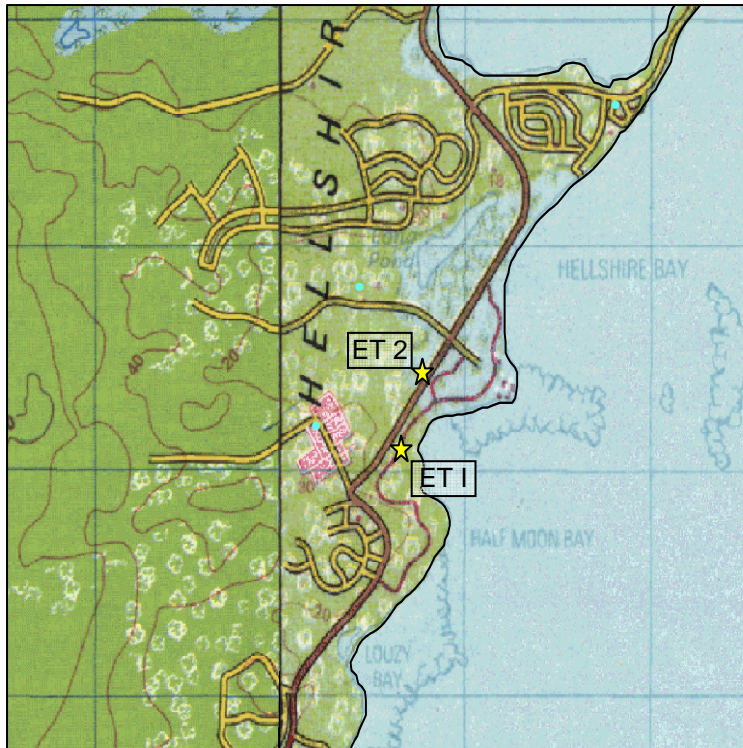
Figure 16: Topographic Plan of Half Moon Bay identifying the proposed ET sanitation facilities. The natural sand road identified on the map follows along the sand dunes

Five (5) sites were strategically selected within the 10 acre property. Site 1 and 2 are near the bathing and fry fish shed areas. These facilities will be flush toilet systems that will be maintained by the caretaker. Site 1 is an abandoned foundation where goats' currently pasture (Figure 17) and adjacent to the entrance road. Site 2 is the current public toilet that will be transformed into an ET system with more operating toilets. This site requires remodeling of the current public toilet facility from septic tank/holding tank to septic tank/ETB/holding tank and improving the toilet infrastructure. Before converting this toilet system to the proposed, the storage sheds adjacent to the toilet entrance doors (Figure 18) must be removed. Both locations may be easily identified by beach visitors.

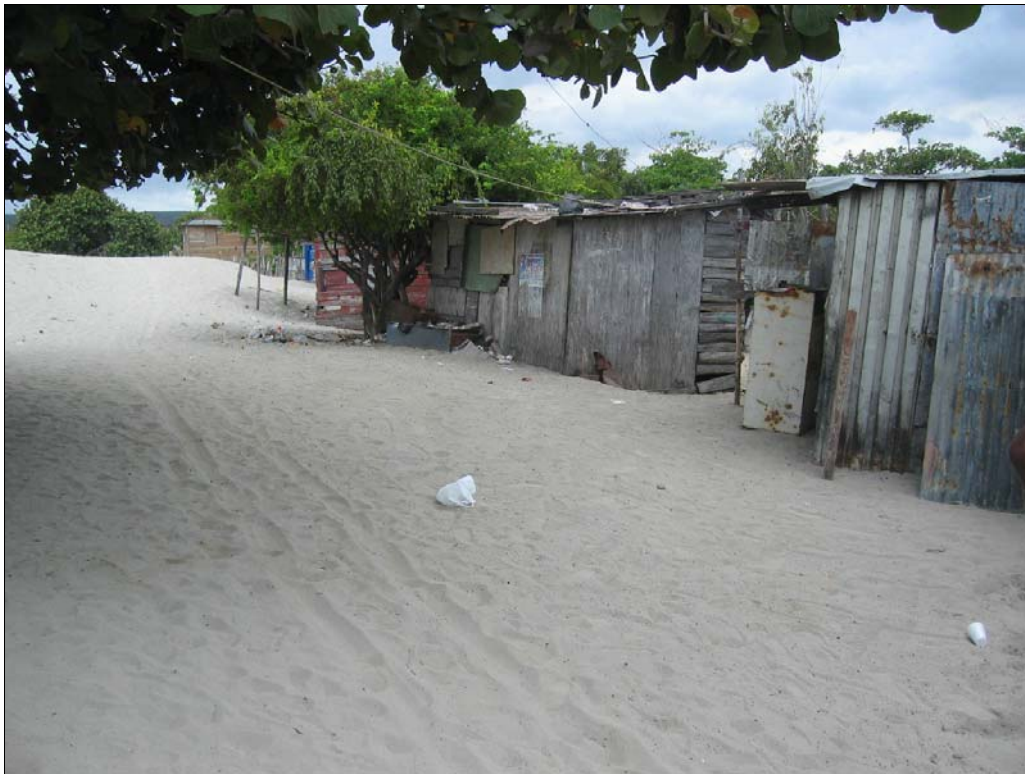
Figure 17: Proposed site for ET System I.

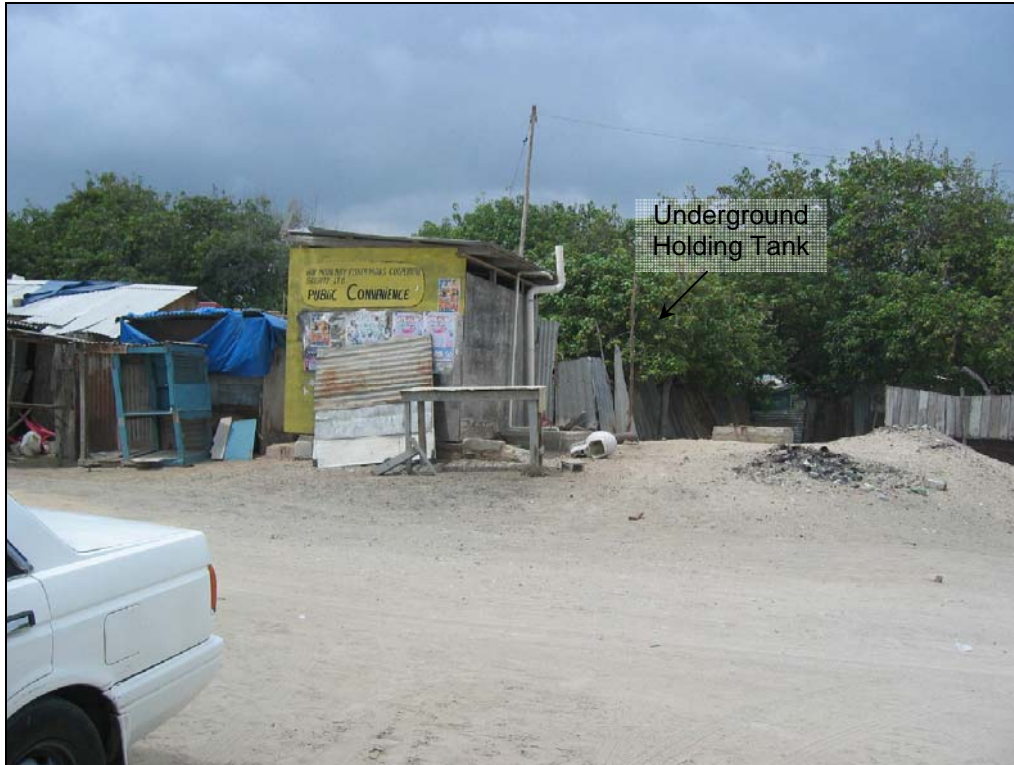
Figure 18: Current Location of Public Toilet & Proposed site for ET System II
