**GEOLOGIC CONTROLS FOR LANDSLIDES IN
THE CENTRAL AMERICAN HIGHLANDS OF
NORTHERN EL SALVADOR**

**By
York W. Lewis**

**Submitted in partial fulfillment of the requirements for the degree of
Master of Science in Geological Engineering**

Michigan Technological University

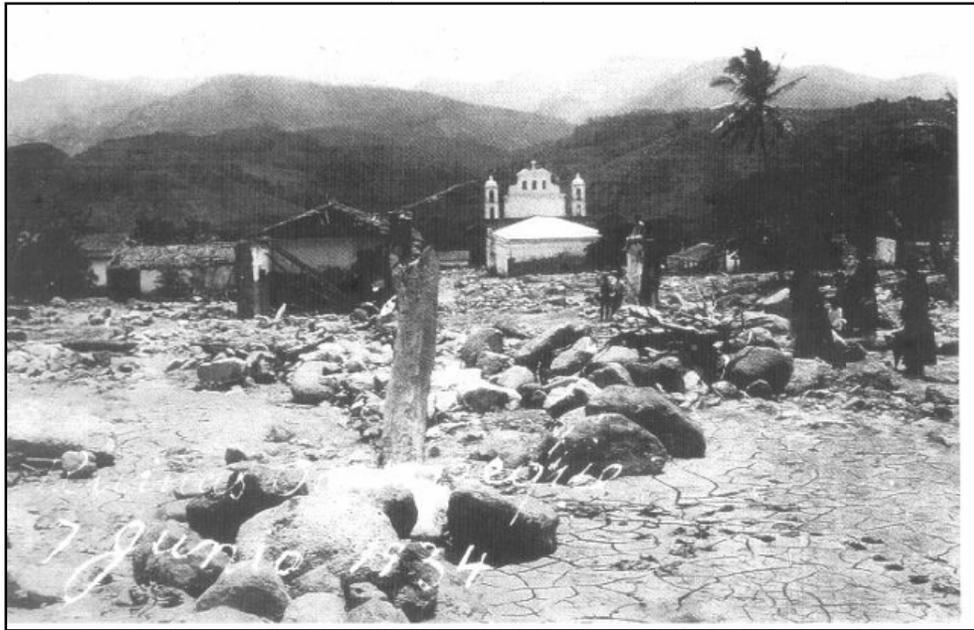
In June of 1934 a landslide occurred near Ocotepeque, Honduras in the upper portion of the Rio Marchala watershed; damming the river. Over a period of eight days, water accumulated behind this natural dam and created a small lake. At approximately 7:00 a.m. on June 7, 1934 the dam broke and flooded the valley downstream toward the city of Antigua Ocotepeque (known as Ocotepeque at that time) (Figure 3). Records of the incident report 3,814 (88% of the city's population) were killed and much of the city was destroyed when flooding reached the town. Reports from the local observers said that only the church, a substantially built structure, was left standing after the debris flow passed through the city. The city, which served as the local government headquarters, was subsequently located approximately four kilometers to the north and renamed Nueva Ocotepeque. Antigua Ocotepeque was shifted by the people several hundred meters to the south of the Rio Marchala in hopes of staying out of the floodplain of the Rio Marchala.

Figure 3 Photo of Antigua Ocotepeque taken in 1934 after the debris flow from Rio Marchala destroyed the city. Only the church appears to be standing.

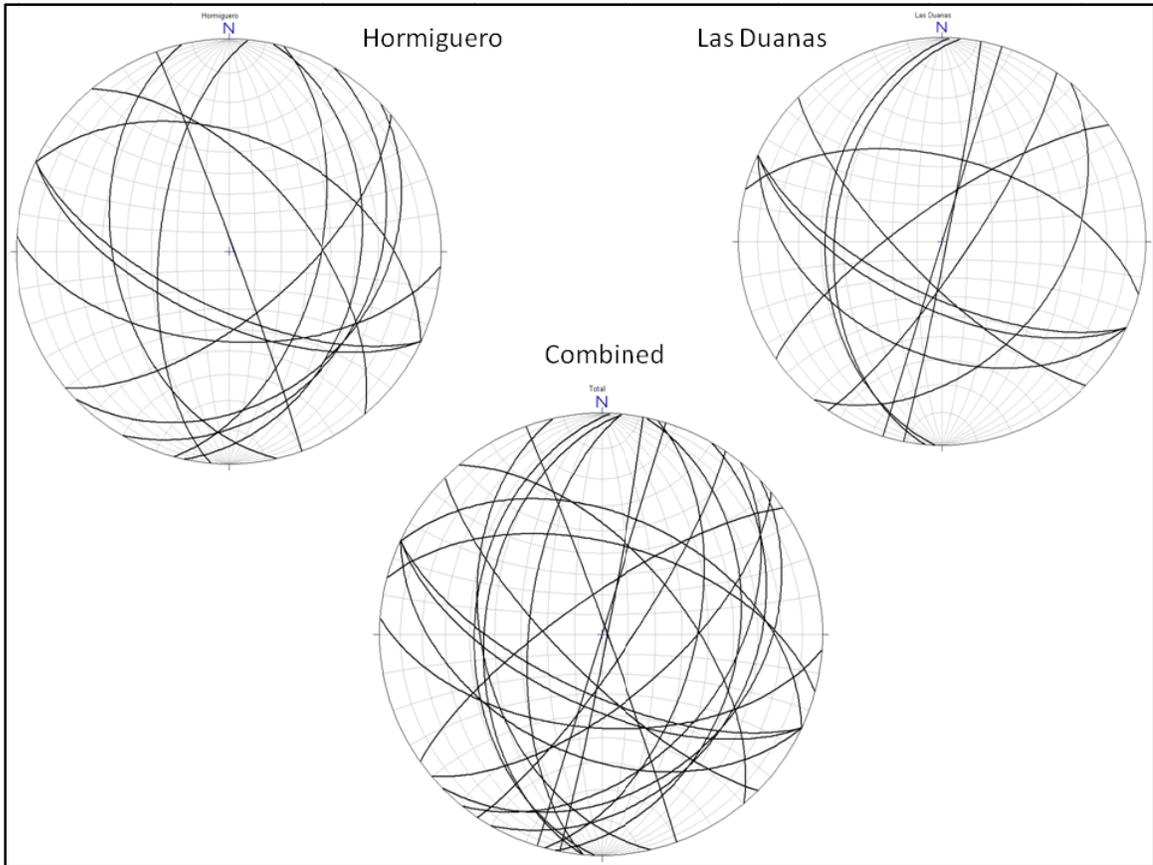
Figure 16 Stereonets representing measured joint and fault orientations for Hormiguero, Las Duanas, and the total combined measurements at both landslides. The majority of orientations dip toward the southeast and southwest. This suggests that rock failure is more likely to occur on the south-facing slopes, though no evidence of rock slides has been observed nor documented. Other orientations represented above parallel the regional fault trends.

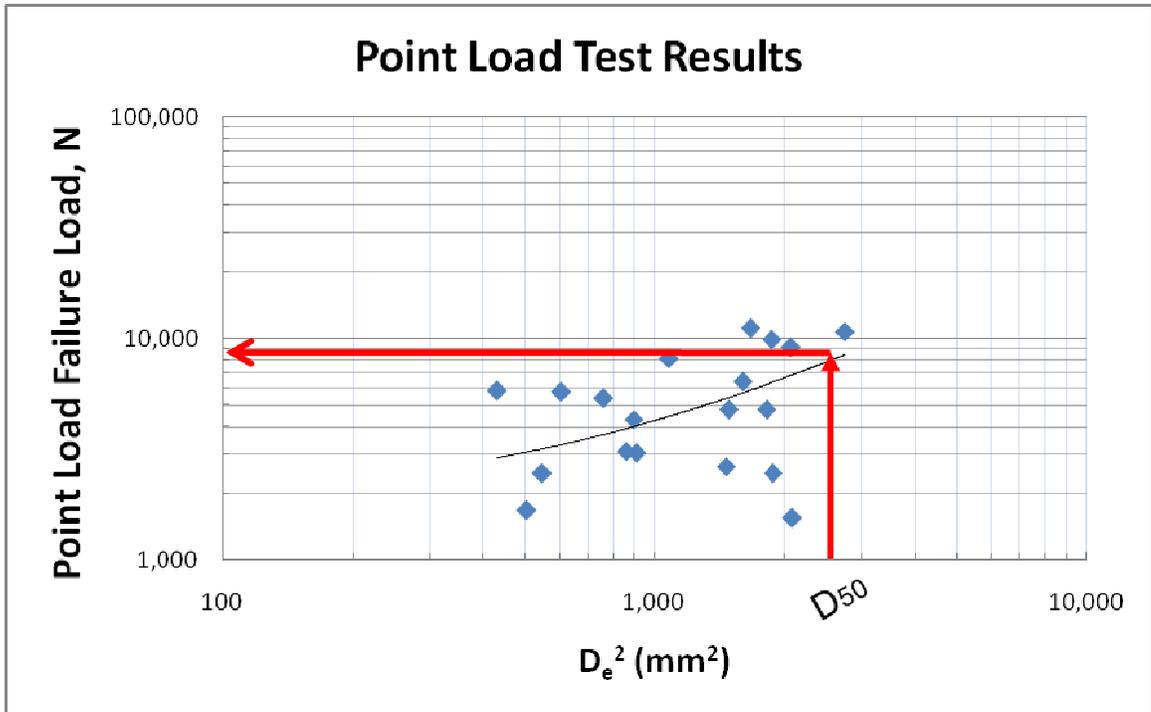
The estimated uniaxial compressive strength for all of the blocks tested is about 73 MPa (10,600 psi). If you eliminate all of the test values below 3,000 N, which could be assumed to have been due to weathering, as seen by discolorations of the ignimbrite sample, then you get a compressive strength of about 86.9 MPa (12,600 psi), which might be a better representation of the ignimbrite non-weathered rock strength.

Figure 17 Point Load Tests of Ignimbrite samples taken from Las Duanas and Hormiguero. Measurements vary due to the changes in degree of weathering.

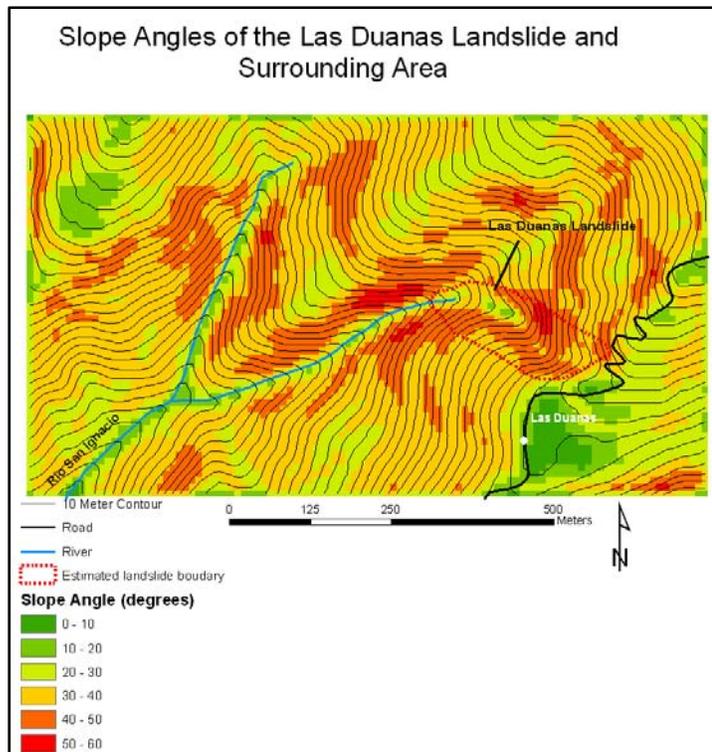
Figure 20 Note the dominant slope angles within the landslide are between 30 and 50 degrees. The surrounding area has slopes that are predominantly between 30 and 50 degrees with a small area that measure more than 5 degrees. These steep slopes are expected to fail like the landslide at Las Duanas. (Spatial data provided by SNET).

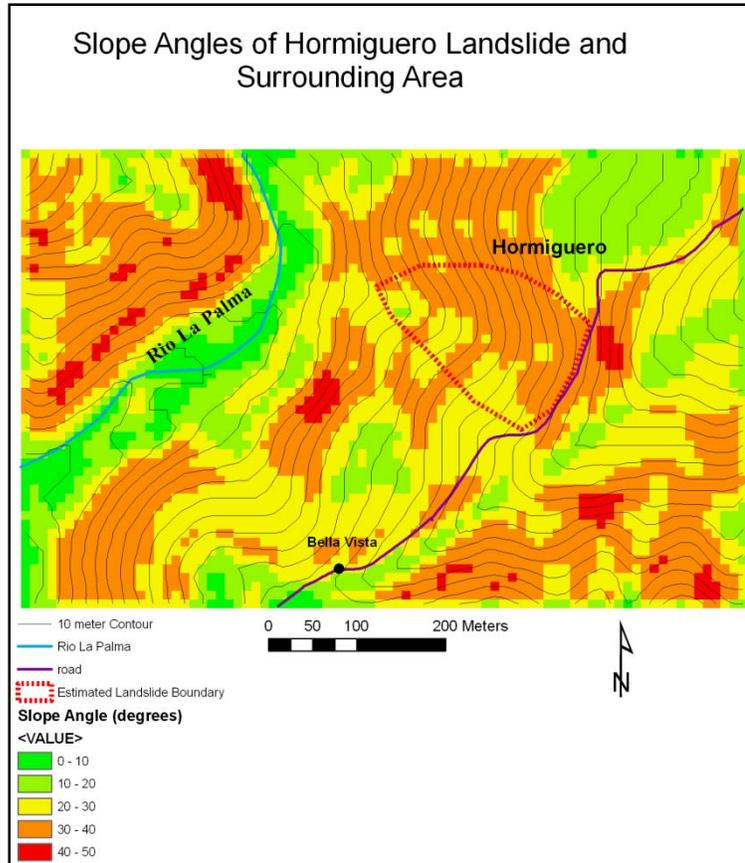
Figure 22 Note that the range of slope angles within the landslide are between 20 and 40 degrees. (Spatial data provided by SNET).

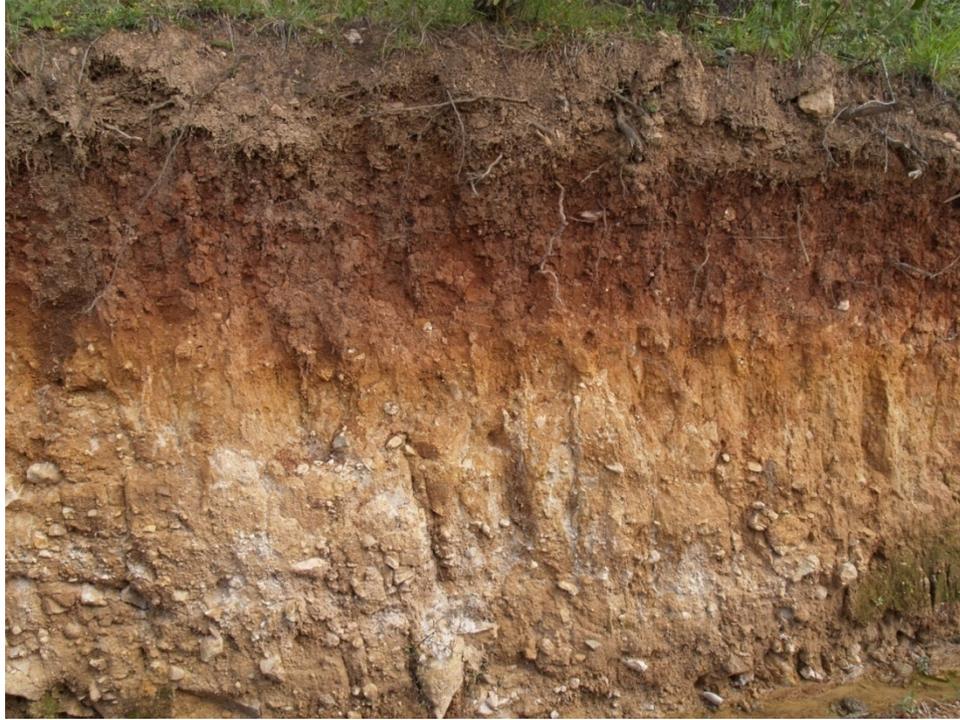
Figure 24 Photo taken by Dr. Stanley J. Vitton of soil profile of a latosols from road cut. Shows red color, thin A horizon and thicker B horizon.

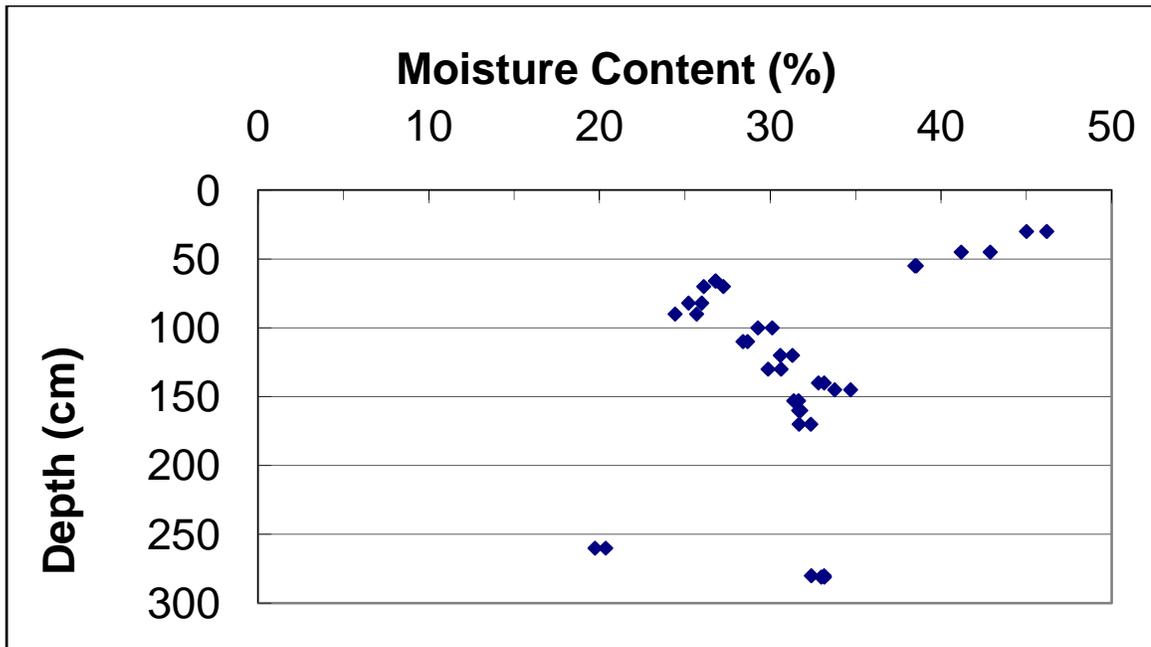
Moisture Content: Moisture contents were measured on 37 soil samples at 19 different depths at the Las Duanas site (Figure 26). Moisture content values range between 20% and 46% and increase with depth. Moisture contents within the first 60 centimeters, though, show the highest moisture contents; ranging from 38% to 46%.

Figure 26 Moisture content of soil at Las Duanas at various depths. Moisture content increases with depth. Higher moisture contents within the first 60 centimeters is attributed to the advanced degree of weathering of the soils to increased clay content.

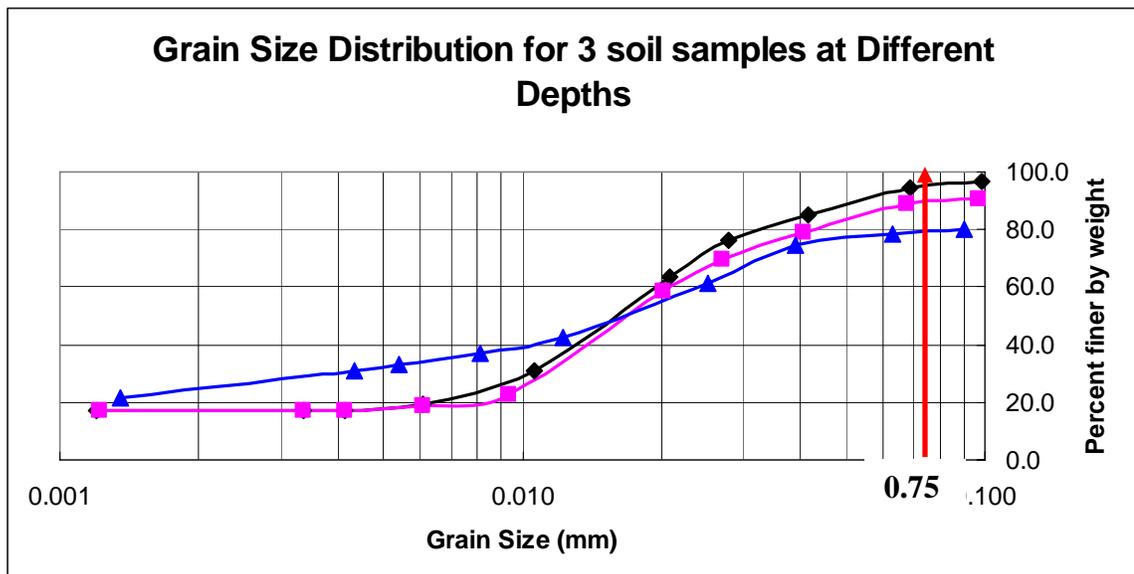
Grain Size Distribution: Grain size distributions for three samples of soil at depths at 66 cm, 145 cm, and 153 cm from the surface, at Las Duanas are shown in Figure 27. Percent passing the #200 sieve at 66 cm depth is 85.7 percent, at 145 cm depth is 76.4 percent, and at 153 cm depth is 63.4 percent.

Figure 27 Grain size distribution of 3 soil samples collected at 66 cm (triangles), 145 cm (squares), and 153 (diamonds) cm the Las Duanas Landslide.

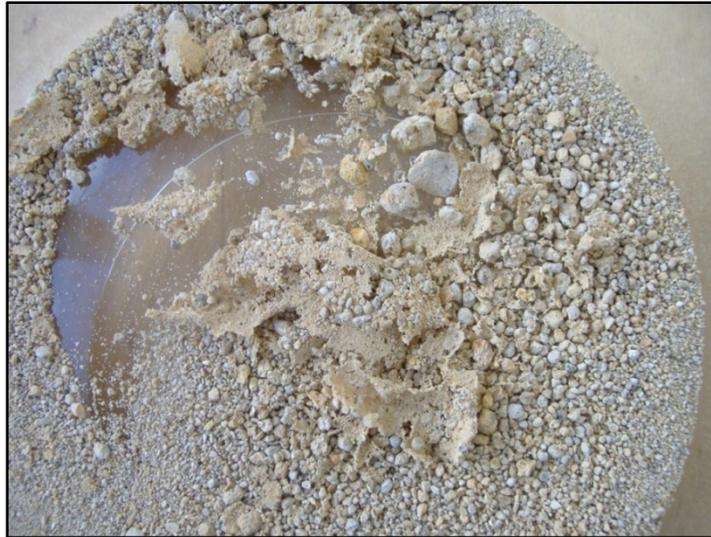
When the washed samples were dried, a thin beige colored film also separated out from the larger particles (Figure 28). Scanning electron microscope images of this film

Figure 28 Photo taken by author of beige-colored film on washed particles larger than #200 sieve.

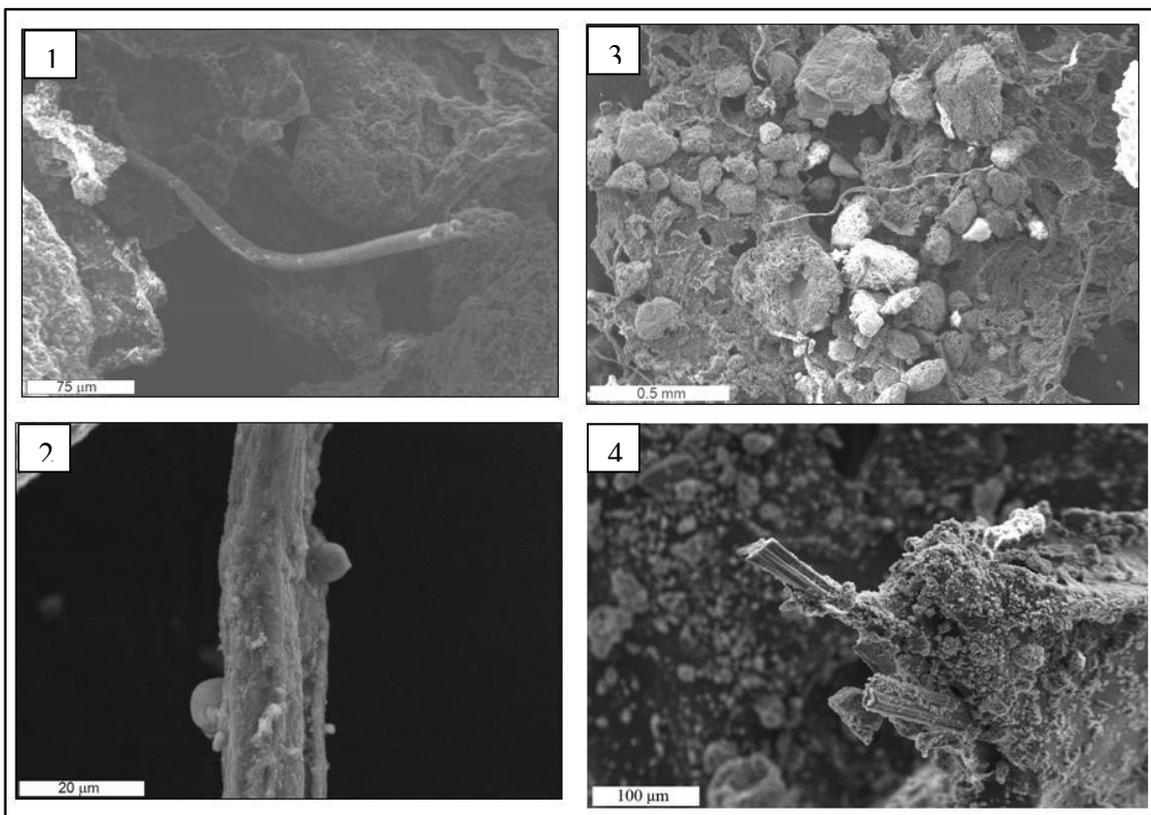
appeared to indicate a mixture of allophane, imogolite and possible halloysite (Figure 29). Research has indicated that in scanning electron microscope images, allophane appears as spherules or clusters of spherules around 50Å that possess strong coulombic attractions which in turn resist shearing, Imogolite appears as solid threads that sometimes adhere together, and halloysite appears as tubes oriented parallel to each other when wet but appear entangle when dried (Rao 1995, Rouse 1986). These structures haven't been confirmed by TEM and therefore we can only suggest the presence of these minerals from the SEM micrographs alone. Past studies have shown that soils developing from andesitic to rhyolitic ashes and in warm, wet climates can generate halloysite, the non-crystalline aluminosilicate, Allophane, and the paracrystalline aluminosilicate, Imogolite. Deflocculation of soils rich in allophane and imogolite is difficult because of the highly adhesive behavior of these clays to each other and the particles which they coat (Rouse 1986). This binding behavior of allophane and imogolite has been shown in previous studies to under estimate the fine-grained proportion of grain-size analyses (Rouse, 1986).

Figure 29 SEM images taken by author of Halloysite develops tubular structure (Photo1), Allophane exhibits spherical structures (Photo 2), and Imogolite exhibits threads that tend to adhere together (Photo4). When dried, Allophane and imogolite coat and bind soil particles together (Photo3).

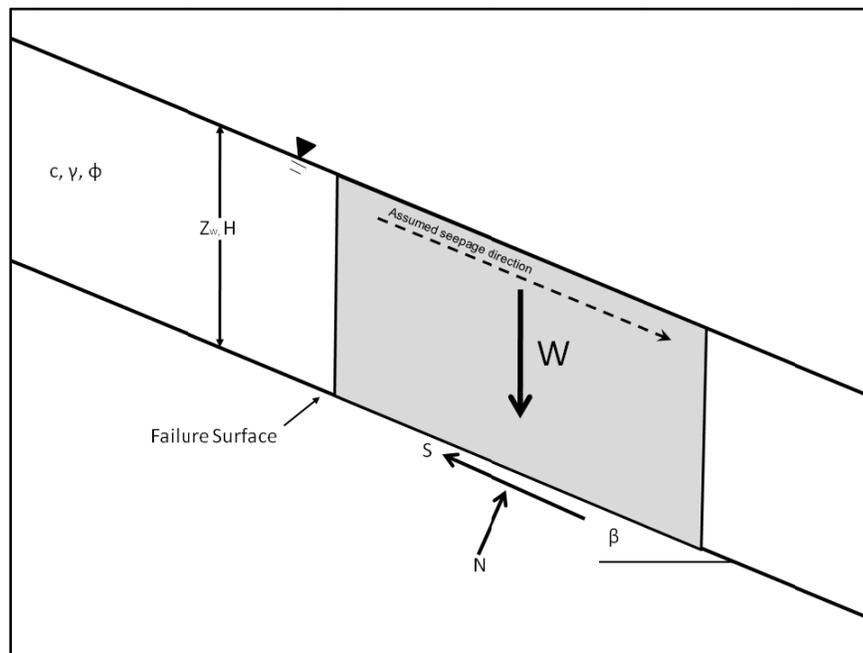
The most probable critical flow condition in the slopes would be parallel to the slope given the impermeability of the underlying ignimbrite rock. Assuming 100% saturation and parallel flow to the slope, a soil unit weight $\gamma = 18.8 \text{ kN/m}^3$, the unit weight of water $\gamma_w = 1000 \text{ Kg/m}^3$, $\beta = 60^\circ$ slope and a soil thickness of $z = 2 \text{ m}$, the factor of safety of the slope drops to 0.98 indicating that these conditions would lead to failure during a rainstorm that is intense enough to fully saturate the slope and cause parallel flow in the slope.

The data provide above shows a worse-case scenario. The average slope angles at Hormiguero are between 30 and 40 degrees. Using equation 3 with a minimum slope angle of $\beta = 30$ degrees, a factor of safety of $F = 1$, and keeping all other parameters the same, we get an effective cohesion of $c' = 12.3$ kPa (265 psf). The average slope angles for Las Duanas range between 40 and 50 degrees. Using equation 3 with a minimum slope angle of $\beta = 40$ degrees, a factor of safety of $F = 1$, and keeping all other parameters the same, we get an effective cohesion of $c' = 15.2$ kPa (317 psf). According to the infinite slope model, a 10 degree difference in slope requires a small change in soil cohesion, 2.9 Kpa.

Figure 31 Geometry of Infinite Slope Analysis; 100% saturation and parallel groundwater flow. Where: N = normal force, S = shear force, W = weight of block.

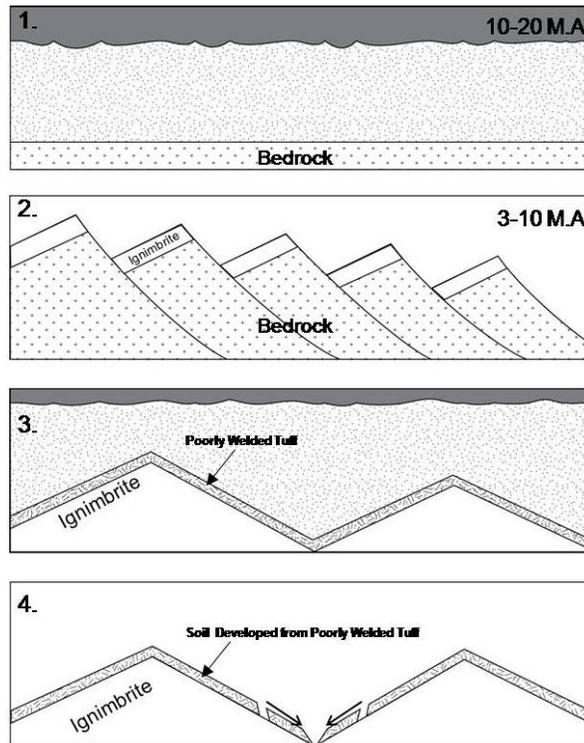
The Central American Highlands and the valleys within them are tectonically controlled. The older northeast-southwest extensional event, caused by either the uplift of the Central American Highlands (Chortis Block) or by plate boundary stresses, that took place after the deposition of the late-miocene ignimbrite created the larger valleys such as the valleys where the Rio San Ignacio and the Rio La Palma rivers flow through (Figure 32), throughout the northern mountains of El Salvador. These older faults have since been truncated by northwest-southeast extensional fault from North America - Caribbean plate boundary stresses. It is within this system of smaller and less developed faults that small valleys form. On the north-facing valleys of this system, landslides form. These valleys are characterized by rapidly developed soils with thicknesses between 2 and 3 meters standing on tectonically controlled slopes of between 20 and 50 degrees. Slope steepness within the region is controlled by the amount of fault displacement of the half-grabens. Since these slopes are steep, as high as 65 degrees, it can be assumed that the amount of displacement is relatively large. As displacement increases, half graben blocks will steepen on the paleosurface and the fault boundaries will flatten out. Since northeast-southwest half-grabens within the region are steeply dipping on the paleosurface to the northwest (Figure 32) we see more landslides.

Figure 32 Illustration showing the geologic formation of the northern mountains of El Salvador. Between 10 and 20 M.A. the late-miocene ignimbrite flare up deposits ash on unknown bedrock (block 1.). Between 3-10 M.A. an extensional tectonic event on the Caribbean plate produces a series of east-west striking half grabens where the rivers La Palma and San Ignacio form (block 2.). Sometime after the east-west extension, the North America-Caribbean plate motion causes the distal extension of northern Central America that forms the northwest-southeast trending Ipala, Sula, and the Ocotepaque grabens and possibly the parallel running smaller valleys within the mountains (not shown). Block 3 shows the blanketing of a poorly welded tuff on the uplifted topography. Soil development of the poorly welded tuff while stream cutting through the poorly welded tuff undercuts the natural buttress created between the opposing slopes (block4). Once buttressing support is removed, soils slide along the paleo-surface of the ignimbrite in a translational manner.
